National Transportation Safety Board

March 18, 2002

Re: OSC File No. DI-01-1889

As you know, Complainant, Henry F. Hughes, an NTSB employee, alleges wrong-doing regarding an NTSB decision not to publish a report he helped to produce. You have provided us a copy of the report, which is entitled "Special Investigative Report: Ground Services Safety Oversight (LAX98SA246)." The report is stamped "DRAFT," and someone has written "1998 investigation conducted by the NTSB LAX office investigative file missing" on the front cover.

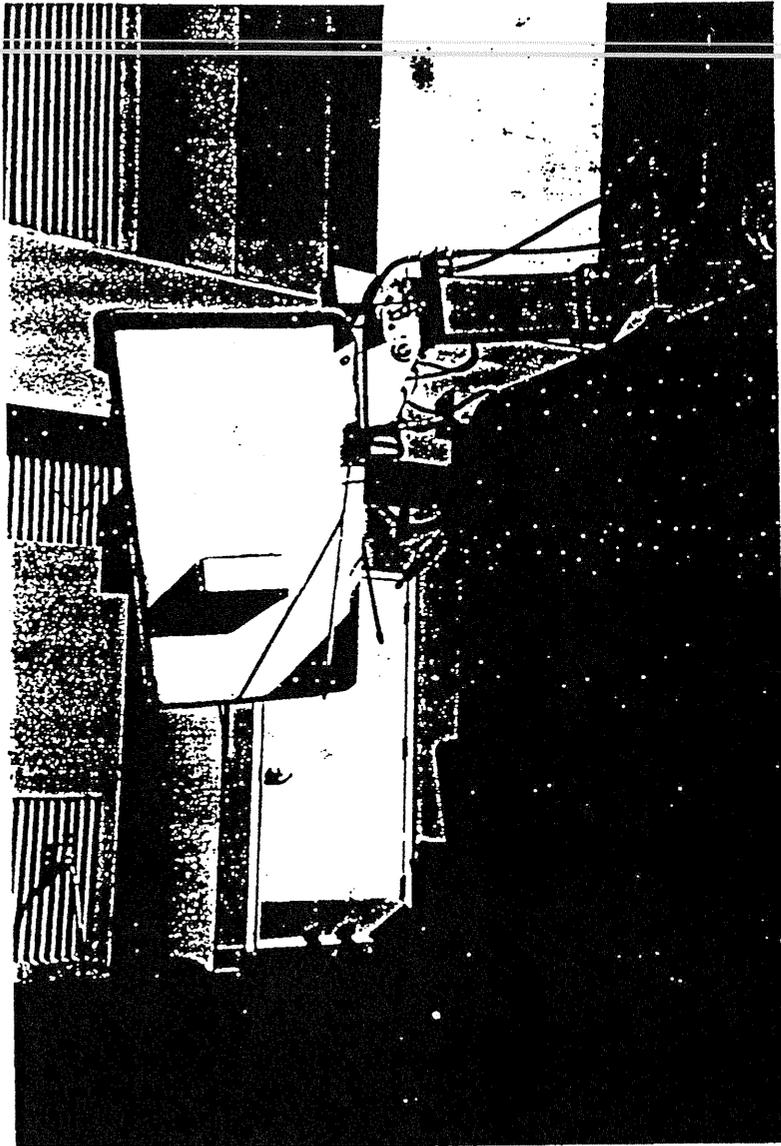
col/report # 12699606  
Date: 12-23-97  
Photo ID#: 9  
Citation #: 2  
Item #: 1  
Instance: a  
Location: Cereal Plant  
Truck, Truck Repair  
Taken By: Kozak

Description: Employee had to climb into bucket by using fixed 2-step ladder  
with 16" frame separation and a 27" step across to the bucket and 26"  
step over into bucket.

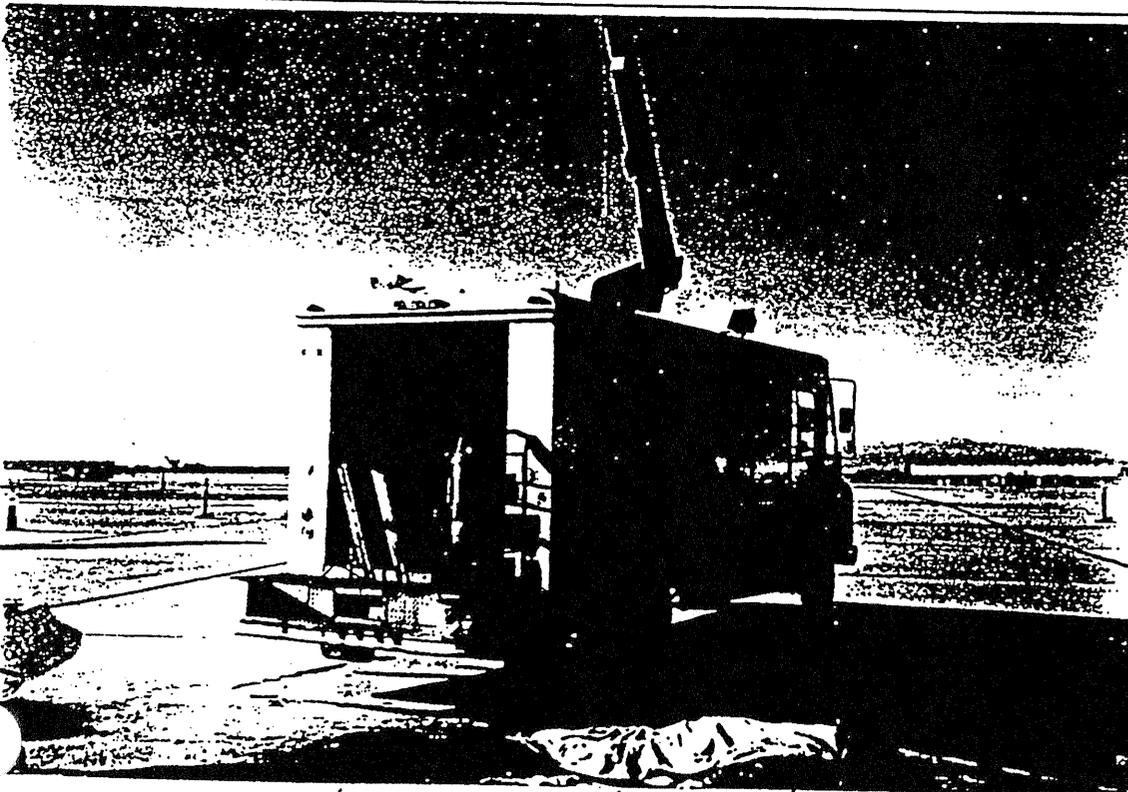
coll/report # 126999606  
Date: 12-23-97  
Photo ID#: 4  
Citation #: 1  
Item #: 1  
Instance:  
Location:  
Taken By: ROZOU

Description: Truck with boom extended when driving underneath aircraft. Employee  
not trained on how to travel with employee in bucket of aerial lift

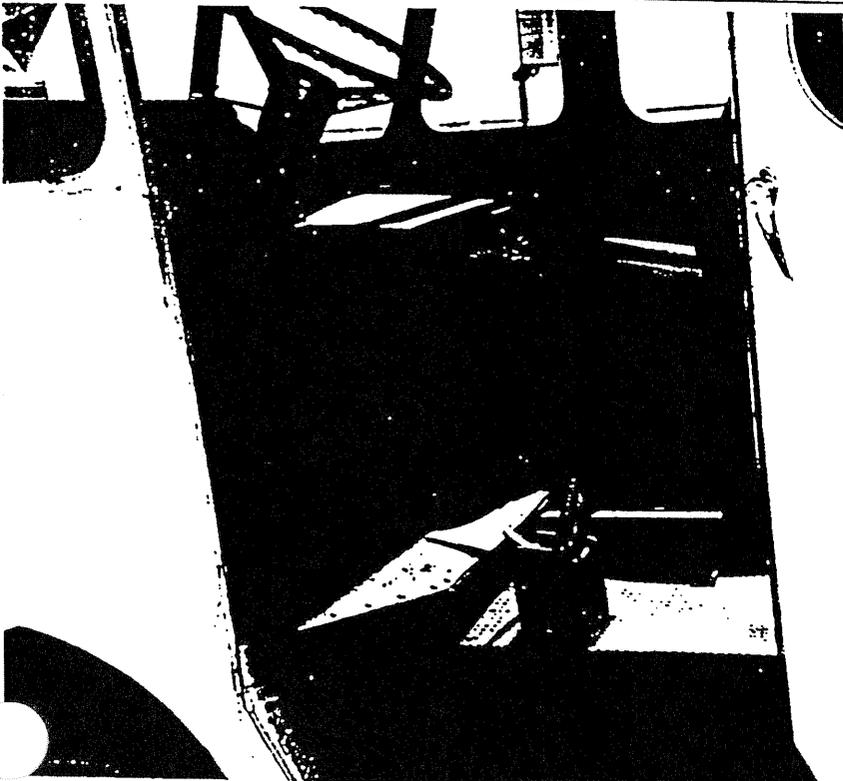
col/report # 12699606  
Date: 12-23-97  
Photo ID#: 2  
Citation #: 1  
Item #: 1  
Instance: a  
Location: Tucson Airport Northwest Parking  
Taken By: ROZOU

Description: Area where vehicle driver of aerial lift would initiate moving truck shown aircraft to communications device with driver to talk to bucket operator via radio. Lower controls were not set to override cockpit controls

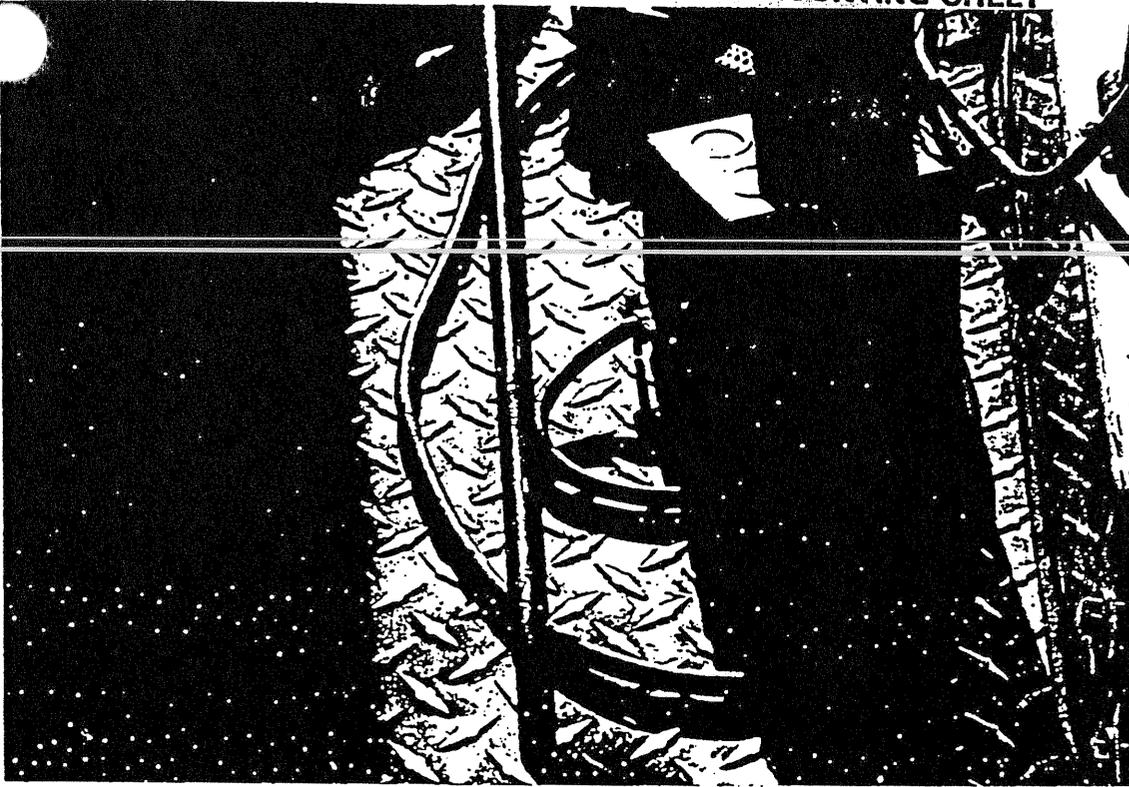
col/report # 12699606  
Date: 12-23-97  
Photo ID#: 10  
Citation #: 2  
Item #: 3  
Instance: 4  
Location: aerial lift  
Truck  
Taken By: ROZOV

Description: Four way junction box attached to flexible cord in a pendant application not authorized per its listing.

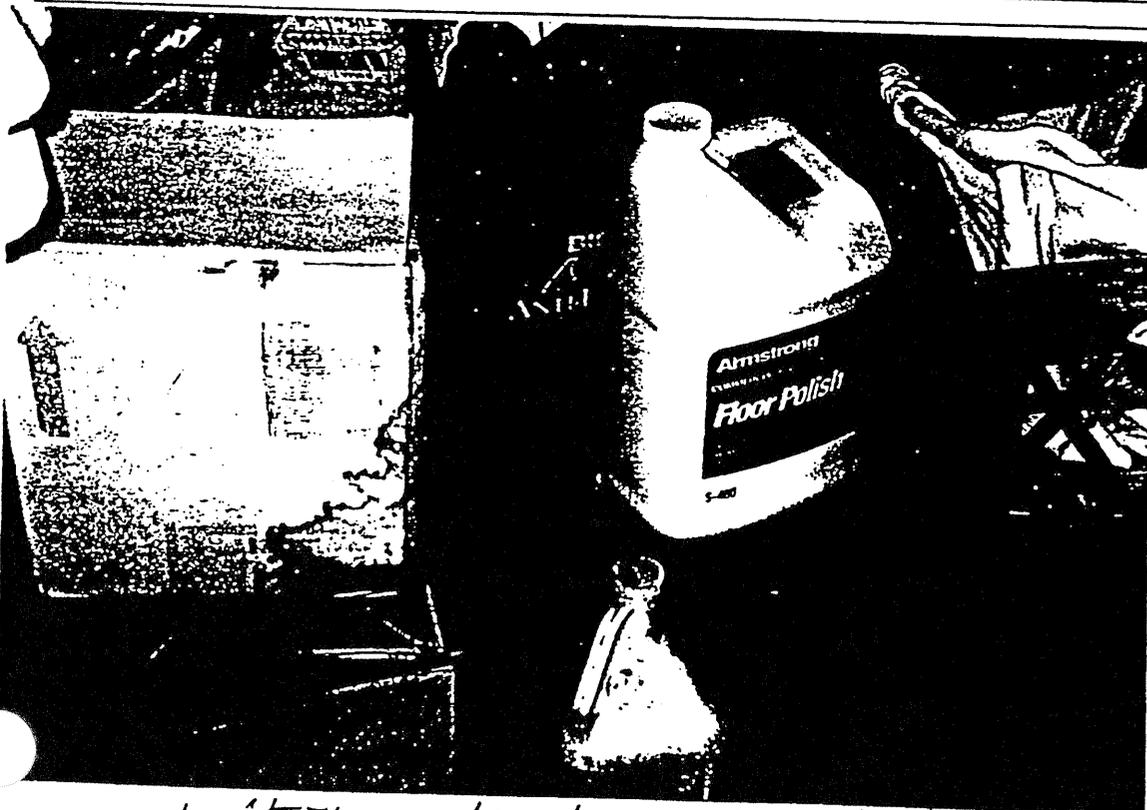
col/report # 126999606  
Date: 12-23-97  
Photo ID#: 13  
Citation #: 2  
Item #: 5  
Instance: 9  
Location: Main office  
area  
Taken By: R0304

Description: Janitorial supplies that employees had received MayCom training on

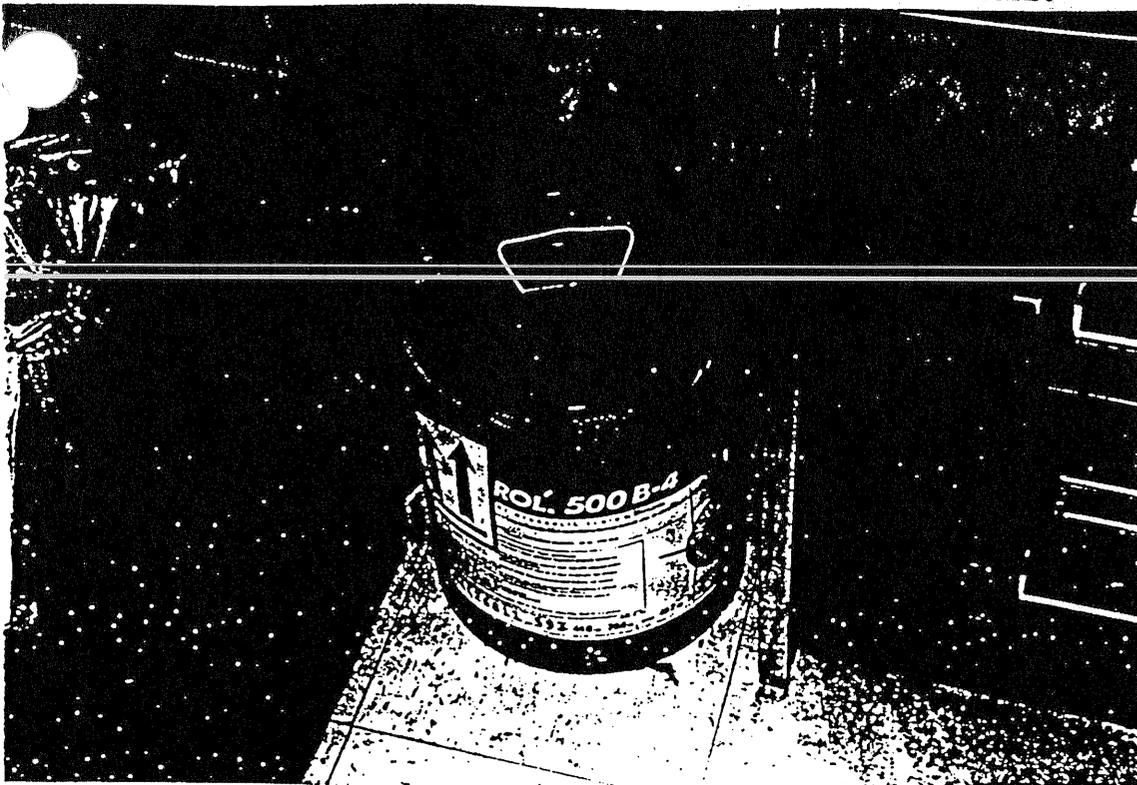
col/report # 12699606  
Date: 12-23-97  
Photo ID#: 14  
Citation #: 2  
Item #: 5  
Instance: 1  
Location: Man Office  
Taken By: PC204

Description: Chemical ROL 500 B-4 which employees had not received  
has been training on
