Office of the Naval Inspector General

NAVINGEN Case Number 20050750
 OSC Case Number DI-05-1175
 NAVAIR Case Number 2005-120

Report of Investigation

Subj: ALLEGED IMPROPER MAINTENANCE PROCEDURES IN THE AV-8B HARRIER
 ENGINE SHOP AT NAVAL AIR DEPOT CHERRY POINT, NC

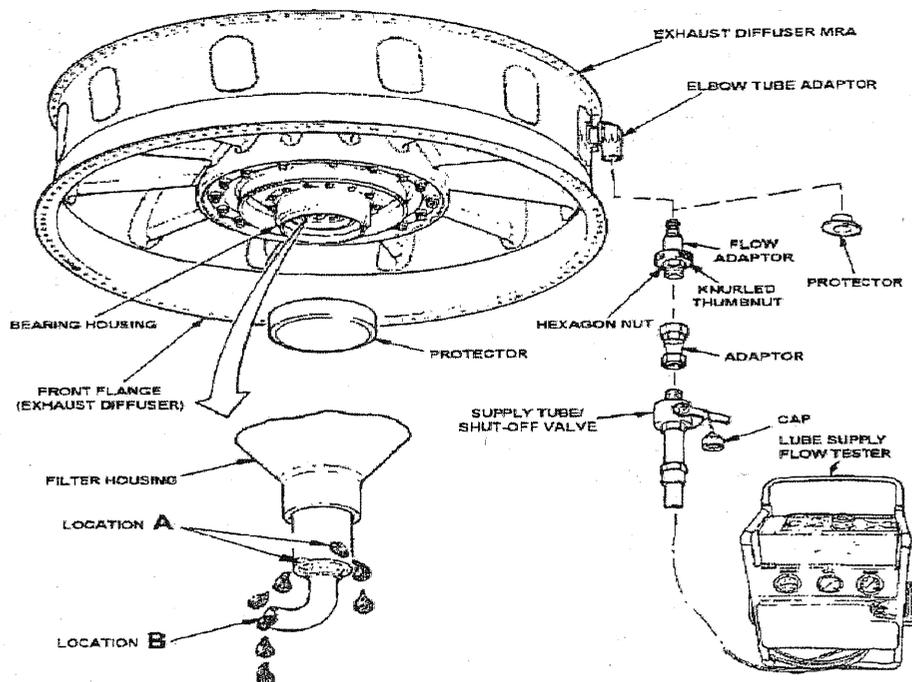
Figure 2: Oil Flow Check Details

31. This diagram, which appears on page 15 of WP 145 00, shows the exhaust diffuser MRA, the lube supply flow tester, the flow adaptor discussed later in this report, and locations A and B, where oil should be observed to "flow freely" from the filter housing during the functional test:

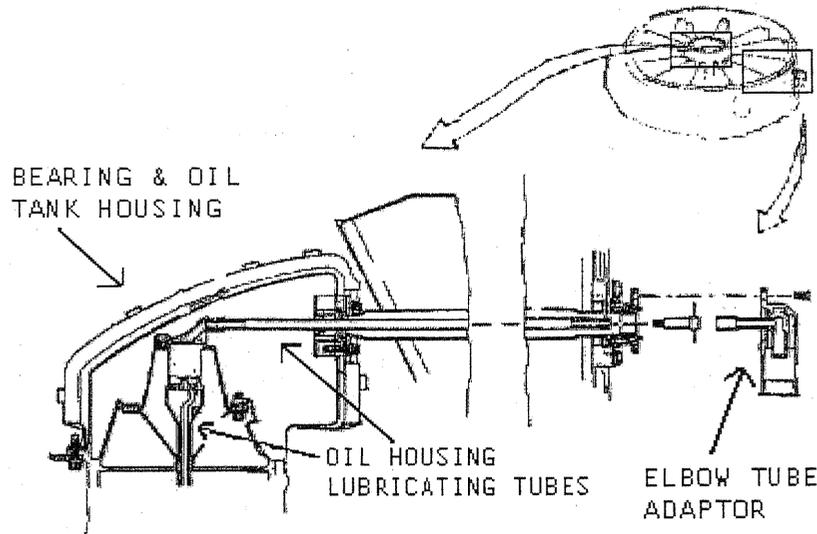
FIGURE 3: ENLARGED CUT-AWAY VIEW OF MRA

100. The following illustration shows the oil passages we understand Artisan-2 is referring to in his discussion of using the oil squirt can to perform a pre-test.
