THE SECRETARY OF THE NAVY
WASHINGTON, D.C. 20350-1000

OSC Case Control Number DI-06-0782
NAVINGEN Case Control Number 20060171
NAVAIR Case Control Number H2006-026

Report of Investigation

Subj: ALLEGED IMPROPER MAINTENANCE PROCEDURES IN THE F/A-18 HORNET
GENERATOR CONVERTER UNIT (GCU) SHOP AT NAVAL AIR DEPOT NORTH
ISLAND, CA (NADEP, NI)

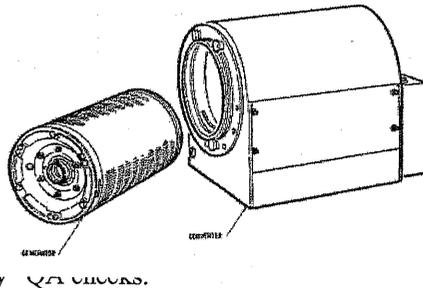
Figure 1. Generator and Converter Unit

22. The GCU, shown in **Figure 1**, consists of two principal assemblies, a generator and a converter, packaged in one unit.

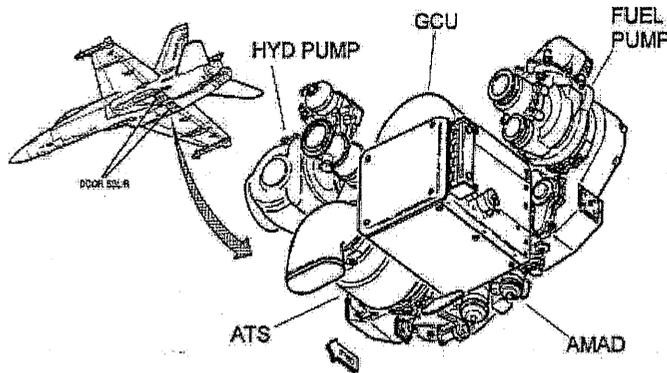
Figure 7. Generator Converter Unit Installed in AMAD

39. **Figure 7** below shows the GCU installed in an AMAD and illustrates the location of the AMAD relative to its installation in an F/A-18. **Figure 8** is an exploded view of the AMAD.

Generator Converter Unit (GCU) Location:

- Inside Doors 53 L/R
- Attached to and is mechanically driven by the Airframe Mounted Accessory Drive Unit (AMAD)

⁷ The statement is factually incorrect. As noted in figure 7 supra, the GCUs are mounted in an Airframe Mounted Accessory Drive Unit, which itself is mounted internally inside the fuselage at the rear of the wing root.
