RESPONSE BY MARIA GARZINO

TO: DoDIG REPORT NO. D-2008-TAD-005

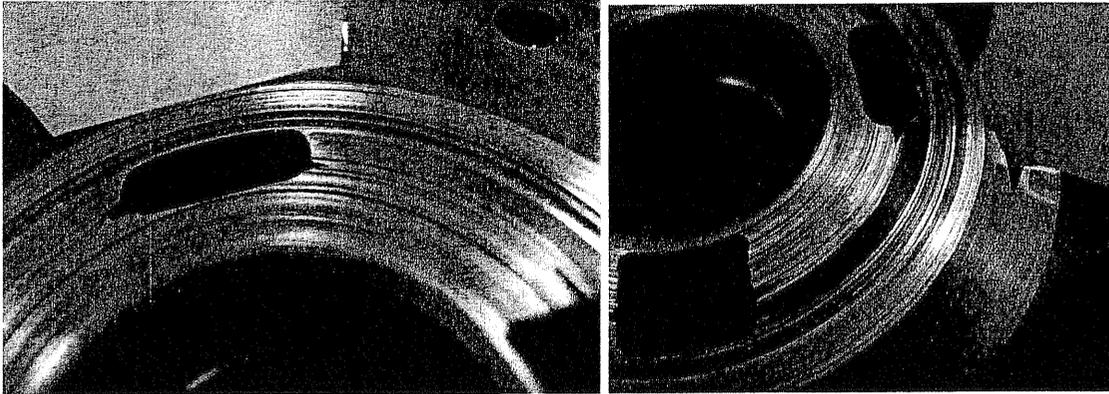
For the Denison hydraulic pump configuration chosen by Moving Waters Industries Corp. (MWI), the design of the hydraulic system was proven to be flawed. The inlet pressure at the Denison pumps was calculated to be insufficient, thereby causing the pumps to suck in air and self-destruct.

Failed port plates due to design flaw (as found in the field – New Orleans, LA):

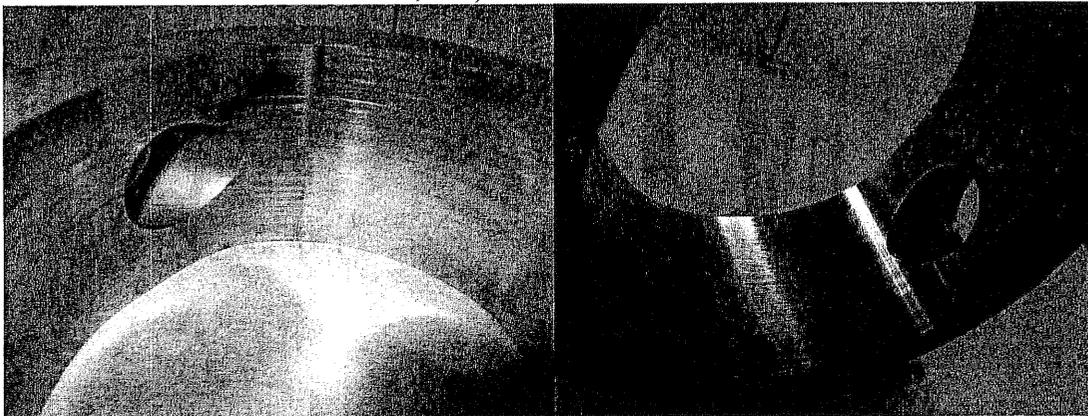
Failed/Failing severely worn cams (unsuitable for further service) due to design flaw (as found in the field - New Orleans, LA):
