Office of the Naval Inspector General

OSC Case Number DI-08-0177
NAVINGEN Case Number 20070925
NAVAIR Case Number H2007-170
FRCSE Case Number H2007-096

Report of Investigation

Subj: ALLEGED SYSTEMATIC ABUSE OF MAINTENANCE AND CERTIFICATION PROCEDURES, INCLUDING THE UNLAWFUL DISPOSAL OF HAZARDOUS MATERIAL AND IMPROPER CLEANING AND REPAIR OF JET ENGINES AT FLEET READINESS CENTER SOUTHEAST (FRCSE), JACKSONVILLE, FLORIDA.

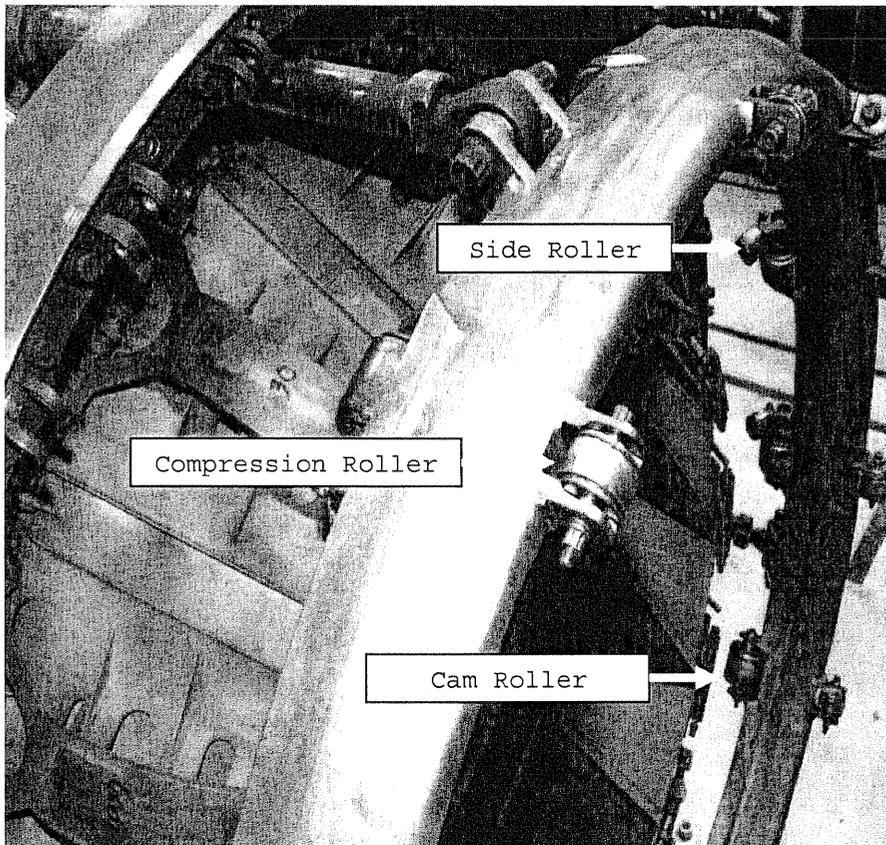
**Figure 2 Illustrates Rollers on VEN of F414 Engine
Maintenance Requirements**

17. Figure # 2 is a photograph of a VEN showing the rollers.⁵

23. Pages 6 through 9 of Work Package 217 establish that rollers are not to be repaired. If a roller is found to be defective, it is to be replaced.

24. Mechanic One, an artisan who has been removing and cleaning actuator rollers on F404 and F414 engines for seven years, told the investigators he removes corrosion from the actuator rollers by brushing them lightly with a wire brush. He then cleans and wipes the rollers with high-temperature grease and ensures the rollers rotate.

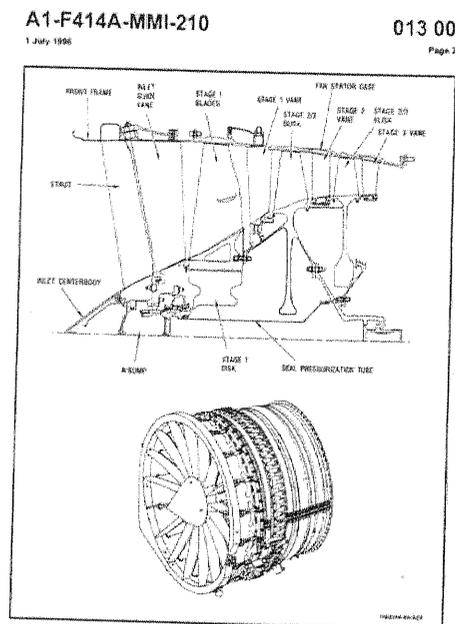
Figure 3 Fan Stator Assembly Containing Vanes/Blades

b. Stage 1 Vanes: There are 68 stage 1 vanes. The stage 1 vanes are variable angle with a total travel of 50 degrees. The inner spindles of the vanes are housed in a split shroud which is axially bolted together. During engine operation, the stage 1 vane shrouds mate with the seal teeth on the forward side of the stage 2/3 blisk, preventing the recirculation of air (figure 3).

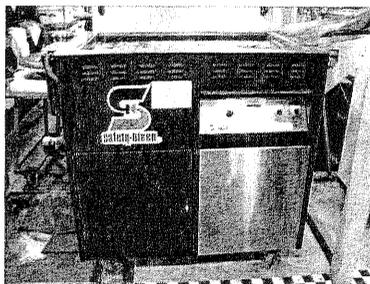
Figure 4 Steam Cleaning Immersion Tank

60. The immersion tank for cleaning fan vanes/blades (see Figure 4 below, item # 24 Appendix A) is an authorized cleaning process (CM3) and has been used in the past at FRCSE. However, the fan vanes/blades are small parts and when they were put in the baskets in the immersion tank for cleaning the fan vanes/blades fell through the basket, to the bottom of the tank during the cleaning process. The tank had to be drained and the fan vanes/blades had to be removed from the bottom of the tank. This was time consuming and required excessive water consumption.

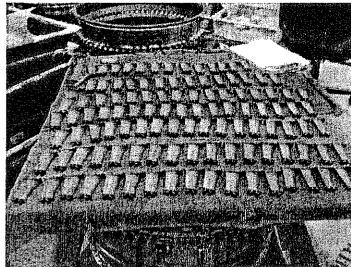
Figure 7 Drying of Fan Stator Vanes

65. The fan vanes are laid out to dry as shown in Figure 7.¹⁹
