Vincent M. Sugent
7768 Pleasant Lane
Ypsilanti, MI 48197
November 26, 2012

Karen Gorman
Deputy Chief, Disclosure Unit
U.S. Office of Special Counsel
1730 M Street, N.W., Suite 300
Washington, D. C. 20036-4505

Thank you again for your time, patience and effort in addressing safety issues and improprieties with Detroit Tower and the Agency. The following is offered as comments for DI-11-0165 and DI-11-1675.

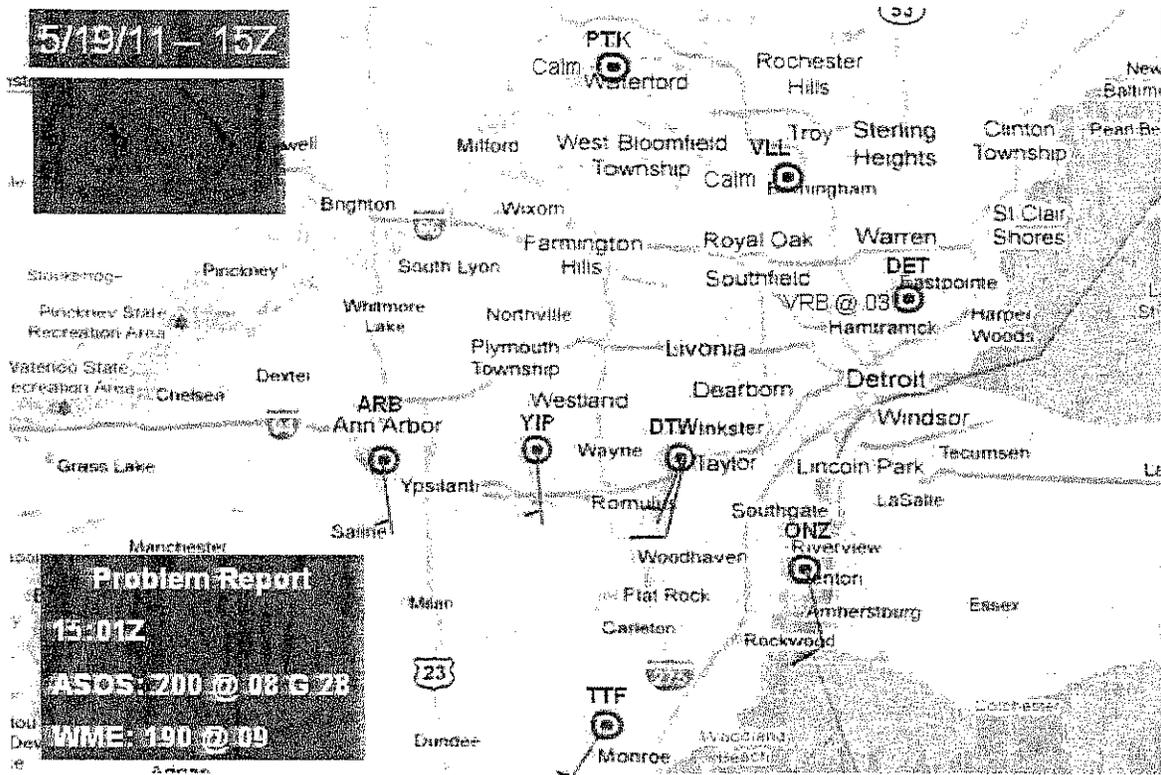
Figure 3 – Hourly METAR Summary for May 19, 2011 (15:00 UTC)

A closer look at the DTW METARs show no gusts reported in any hourly observation for the entire day. The DTW ASOS is augmented by a contract weather observer. The contract weather supervisor, Ed Burney, was contacted and confirmed that the contract weather observers have the ability to remove invalid wind gusts if they are perceived to be inaccurate utilizing other available wind sources (e.g., airport wind socks). If the peak winds on the ASOS, seen in the ATCT during the problem report, were not contained in the hourly METAR then the contract weather observer determined it was invalid and was removed.

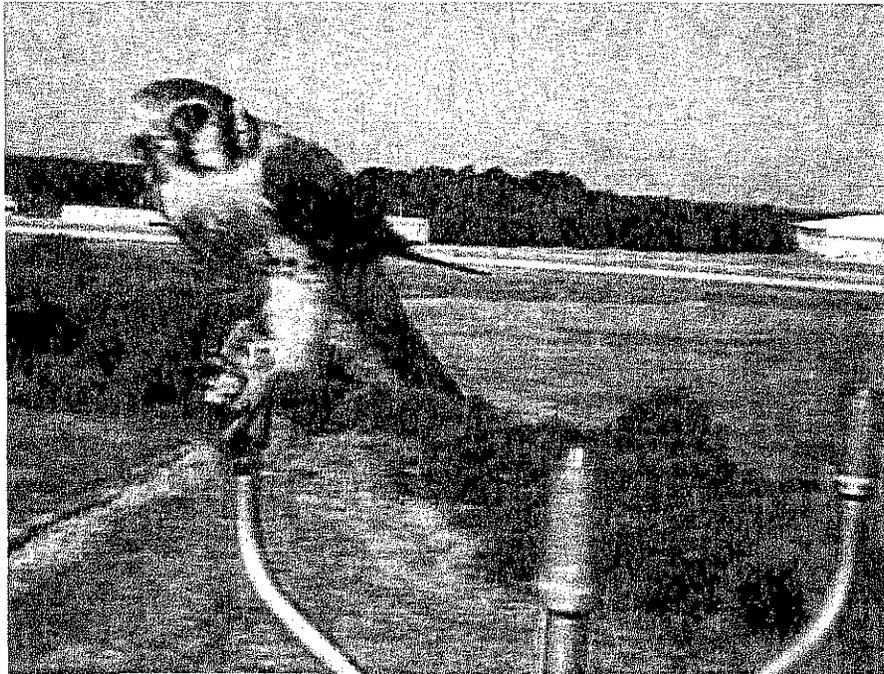
Figure 4 – Example of bird perching on ultrasonic anemometer transducer

In the July 2011 document, (Attachment 3), the Agency states, *"The ultrasonic anemometers use sound waves transferred between three transducers to calculate wind speed and direction. When one or all of these paths are broken, say from a bird landing on the anemometer (Figure 4), the internal sensor firmware occasionally reports inaccurate wind speeds."* It is also our opinion that if they cannot control the birds and the incorrect readings they cause, the ASOS wind should be taken out of service.

To determine what caused the false wind gusts, the NWS in Detroit was contacted and they confirmed having seen bird interference with the ultrasonic anemometer used on the ASOS. These anomalies involve birds landing on the anemometers. The ultrasonic anemometers use sound waves transferred between three transducers to calculate wind speed and direction. When one or all of these paths are broken, say from a bird landing on the anemometer (Figure 4), the internal sensor firmware occasionally reports inaccurate wind speeds. The FAA uses the same style ultrasonic anemometers on a number of automated weather systems and has documented similar problems with birds. No gusts were falsely reported on the WME because the anemometer used is mechanical in nature and not affected by birds.

It is the belief of the meteorologist investigating this problem report that the cause of the differences in wind readings between the WME and ASOS on May 19, 2011 at 15:01 UTC was bird activity on ASOS anemometer transducers.

If the Agency wants to have redundancy, then collocate the equipment in the location at the approach end of Runway 4 Right. The Agency even admits that the systems are nearly 7,000 feet apart, or over 7,000 feet apart depending on what page you read, and does not expect the readings to be exact. Why are wind redundancy systems 7,000 feet apart, being sheltered by buildings and effected by birds?
