Office of the Naval Inspector General

OSC Case Number DI-08-0177
NAVINGEN Case Number 20070925
NAVAIR Case Number H2007-170
FRCSE Case Number H2007-096

Report of Investigation

Subj: ALLEGED SYSTEMATIC ABUSE OF MAINTENANCE AND CERTIFICATION PROCEDURES, INCLUDING THE UNLAWFUL DISPOSAL OF HAZARDOUS MATERIAL AND IMPROPER CLEANING AND REPAIR OF JET ENGINES AT FLEET READINESS CENTER SOUTHEAST (FRCSE), JACKSONVILLE, FLORIDA.

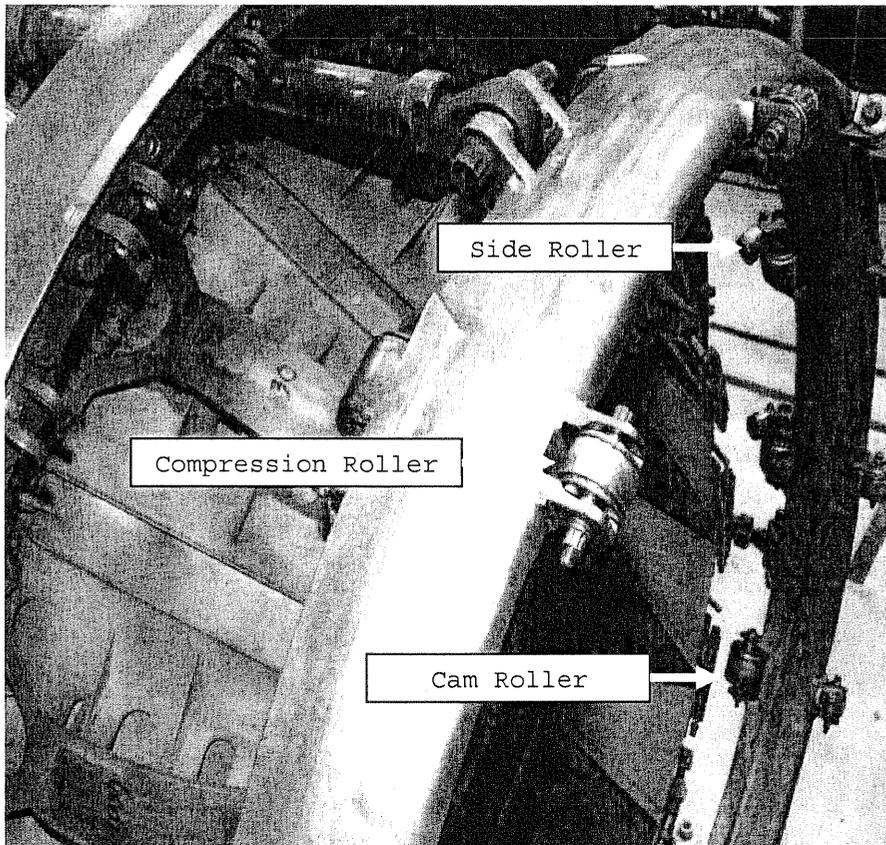
**Figure 2 Illustrates Rollers on VEN of F414 Engine
Maintenance Requirements**

17. Figure # 2 is a photograph of a VEN showing the rollers.⁵

22. No special equipment is specified for cleaning VEN rollers in A1-F414A-MMI-240, Work Package 217 (hereafter Work Package 217). It does indicate a vise with locally manufactured adapter plates should be used when lubricating VEN rollers. The investigators observed that the vise and plates were physically present in the shop.

23. Pages 6 through 9 of Work Package 217 establish that rollers are not to be repaired. If a roller is found to be defective, it is to be replaced.

24. Mechanic One, an artisan who has been removing and cleaning actuator rollers on F404 and F414 engines for seven years, told the investigators he removes corrosion from the actuator rollers by brushing them lightly with a wire brush. He then cleans and wipes the rollers with high-temperature grease and ensures the rollers rotate.

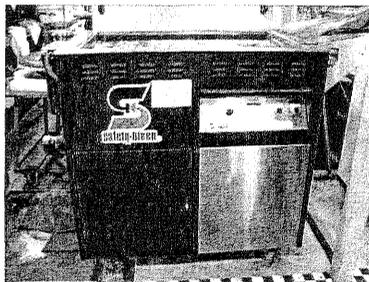
Figure 4 Steam Cleaning Immersion Tank

60. The immersion tank for cleaning fan vanes/blades (see Figure 4 below, item # 24 Appendix A) is an authorized cleaning process (CM3) and has been used in the past at FRCSE. However, the fan vanes/blades are small parts and when they were put in the baskets in the immersion tank for cleaning the fan vanes/blades fell through the basket, to the bottom of the tank during the cleaning process. The tank had to be drained and the fan vanes/blades had to be removed from the bottom of the tank. This was time consuming and required excessive water consumption.

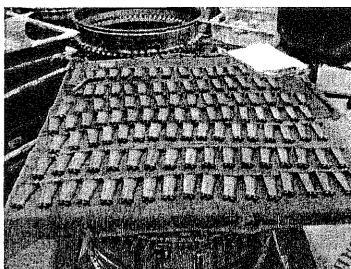
Figure 7 Drying of Fan Stator Vanes

65. The fan vanes are laid out to dry as shown in Figure 7.¹⁹
