Vincent M. Sugent  
7768 Pleasant Lane  
Ypsilanti, MI 48197  
January 9, 2012

Existing and Proposed ASOS and WME Locations  
Detroit Metropolitan Wayne County Airport, MI (DTW)

**Automated Surface Observing System (ASOS)  
and  
Wind Measuring Equipment (WME)**

**Detroit Metropolitan Wayne County Airport  
Detroit, MI (DTW)**

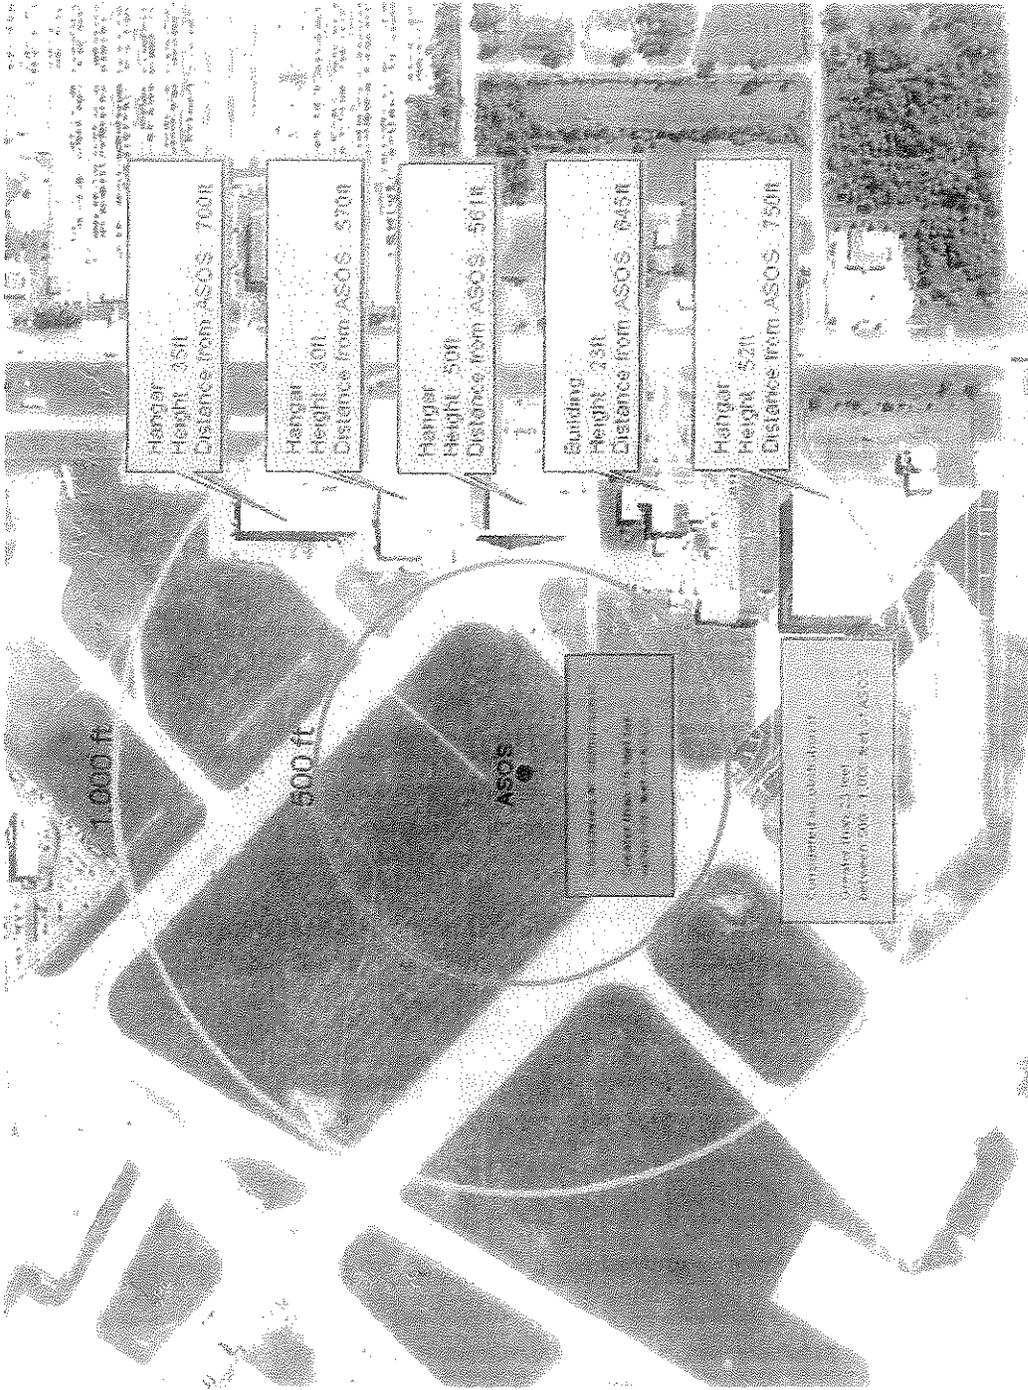
DTV Existing ASOS Site - Obstruction Analysis per ASOS Siting Guidelines (FCM-S4-1994)

A meteorological survey and obstruction analysis were performed at the existing WME and ASOS locations. There were no obstructions noted at the WME location that would adversely affect wind readings. There were a number of aircraft hangars to the east of the existing ASOS location that are likely causing sheltering. Given the height and location of these structures, the DTW ASOS is in violation of the ASOS Siting Order. See pages 4-10 for more details on the evaluation of the existing WME and ASOS locations.

It is the recommendation of AJW-14A, with input from DTW Air Traffic, Tech Ops and the National Weather Service to proceed with the Needs Assessment Program (NAP) entry, initiated by DTW TechOps, to relocate the WME and ASOS wind equipment to the ASOS Data Collection Package (DCP) near Runway 04R glide slope tower. Refer to pages 11-13 for site details, map and photographs.

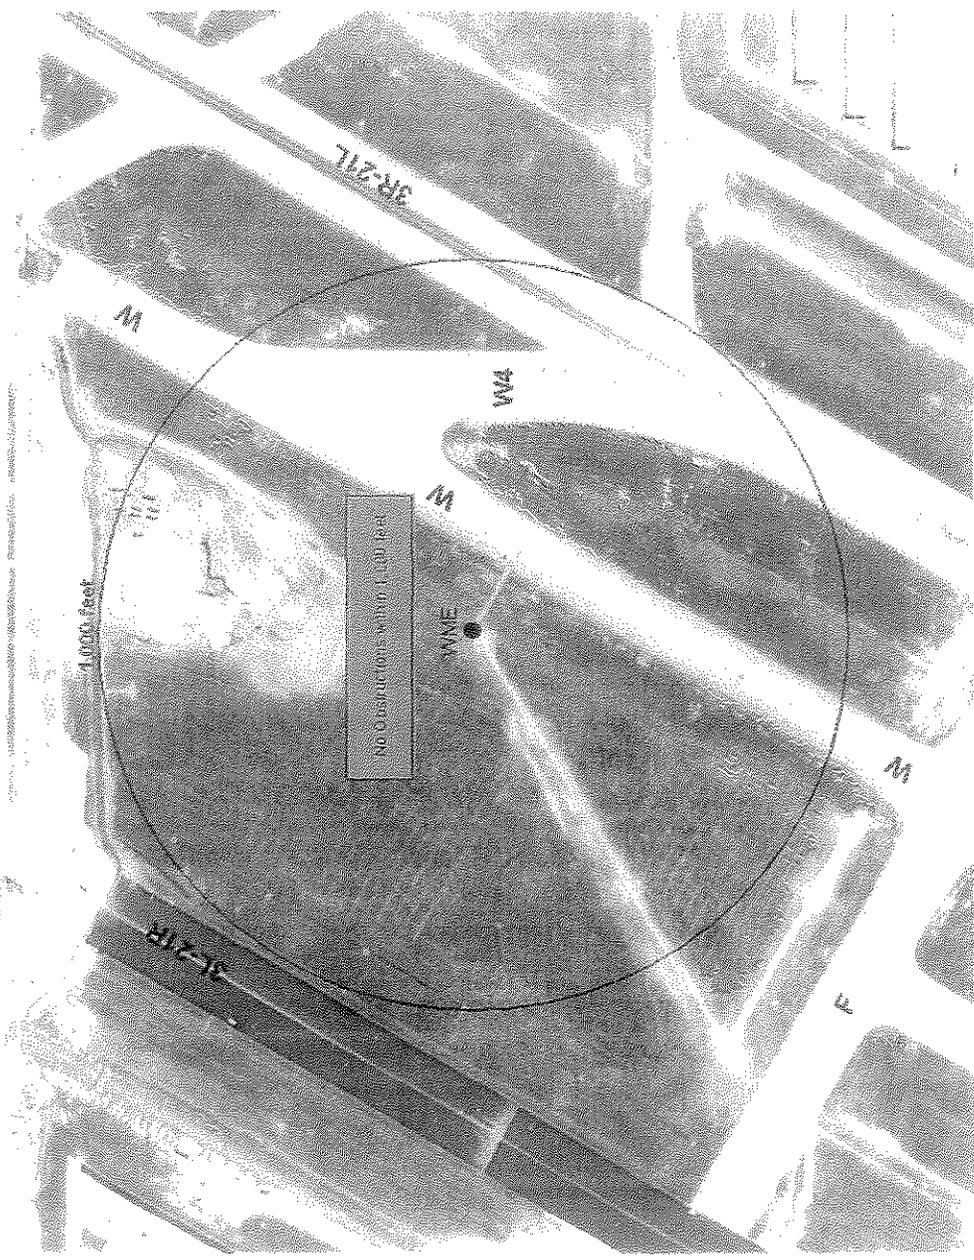
DTW Existing WME Site - Obstruction Analysis per FAA Order 6560.21A

<b>Location</b>			
42° 13' 52.09" N		83° 19' 52.38" W	
<input checked="" type="checkbox"/> GPS Accuracy: ± 20 ft	<input type="checkbox"/> Estimated Method:	<input type="checkbox"/> Other	
Physical Description:			
<b>Condition of Equipment</b>			
<input type="checkbox"/> Excellent	<input checked="" type="checkbox"/> Good	<input type="checkbox"/> Fair	<input type="checkbox"/> Poor
Comments:			
<b>Anemometer Pole Height</b>			
<input type="checkbox"/> Standard Height - 10m (33ft)		<input checked="" type="checkbox"/> Other: 40 feet	
<b>Terrain Features</b>			
<input checked="" type="checkbox"/> Flat	<input type="checkbox"/> Rolling	<input type="checkbox"/> Steep Direction:	<input type="checkbox"/> Other
Comments:			
<b>Obstructions</b>			
No Significant Obstructions			
<b>Remarks</b>			
None

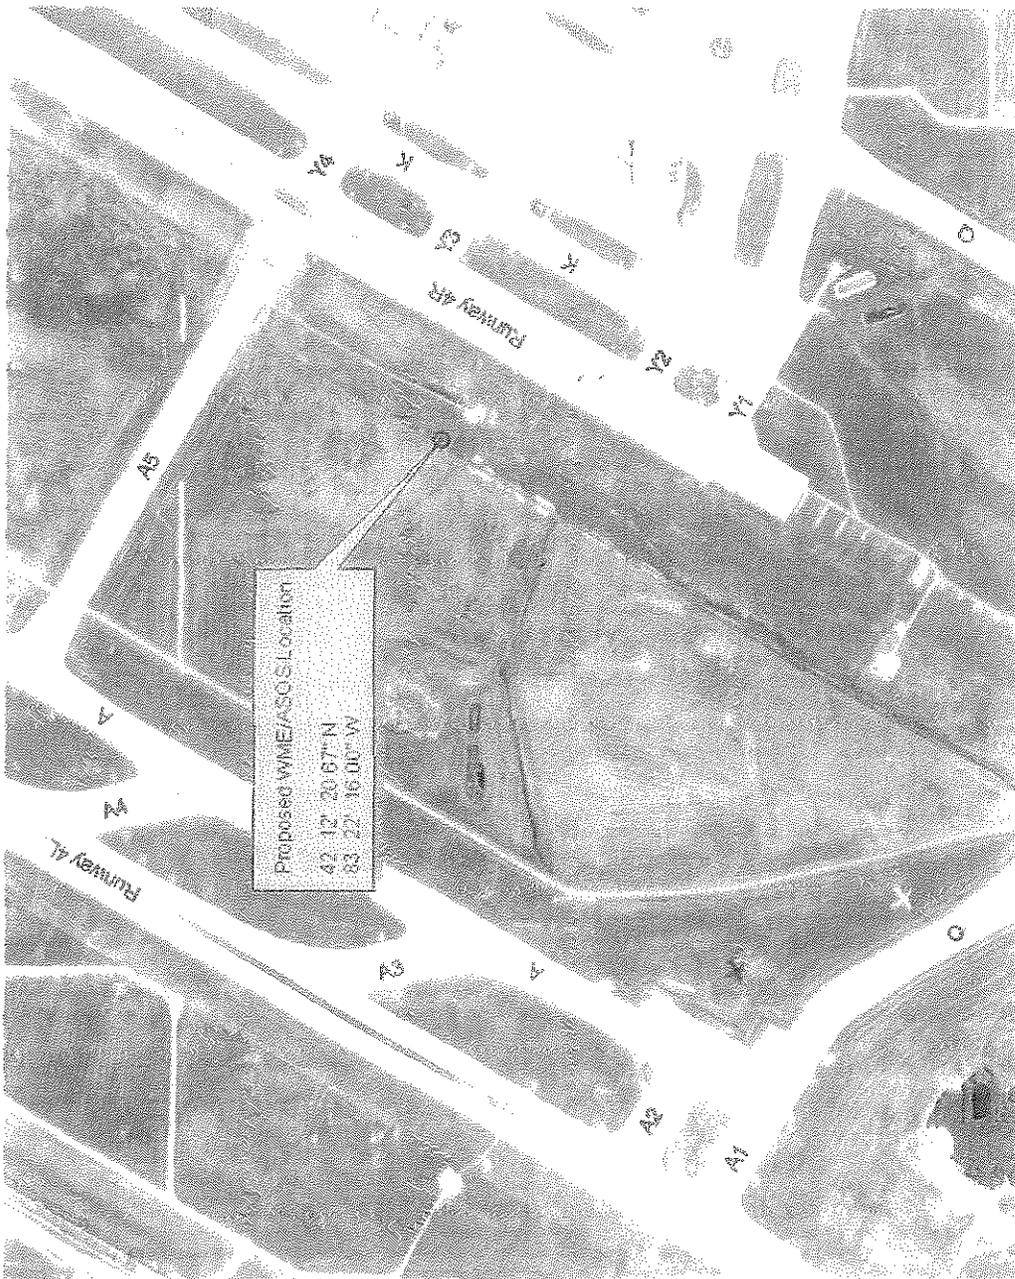
DTW Proposed WME and ASOS Site

A formal survey was conducted to locate a site to co-locate the ASOS and WME. A location near the ASOS Data Collection Package (DCP) near Runway 04R glide slope tower was selected for both systems. No significant obstructions to the prevailing wind in the area were noted. Both anemometers can be installed on 33-foot poles at this location.

<input type="checkbox"/> Other
Comments: Site is accessible via Taxiway A5 and gravel access road.		
<b>Observed Soil Structure</b>		
<input checked="" type="checkbox"/> Stable and Well Drained	<input type="checkbox"/> High Water Table	<input type="checkbox"/> Other
<b>Terrain Features</b>		
<input checked="" type="checkbox"/> Flat	<input type="checkbox"/> Rolling	<input type="checkbox"/> Steep Direction:
		<input type="checkbox"/> Other
<b>Obstructions</b>		
No significant obstructions		
<b>Recommended Pole Height</b>		
10 meters (33 feet)		
<b>Remarks</b>		
None

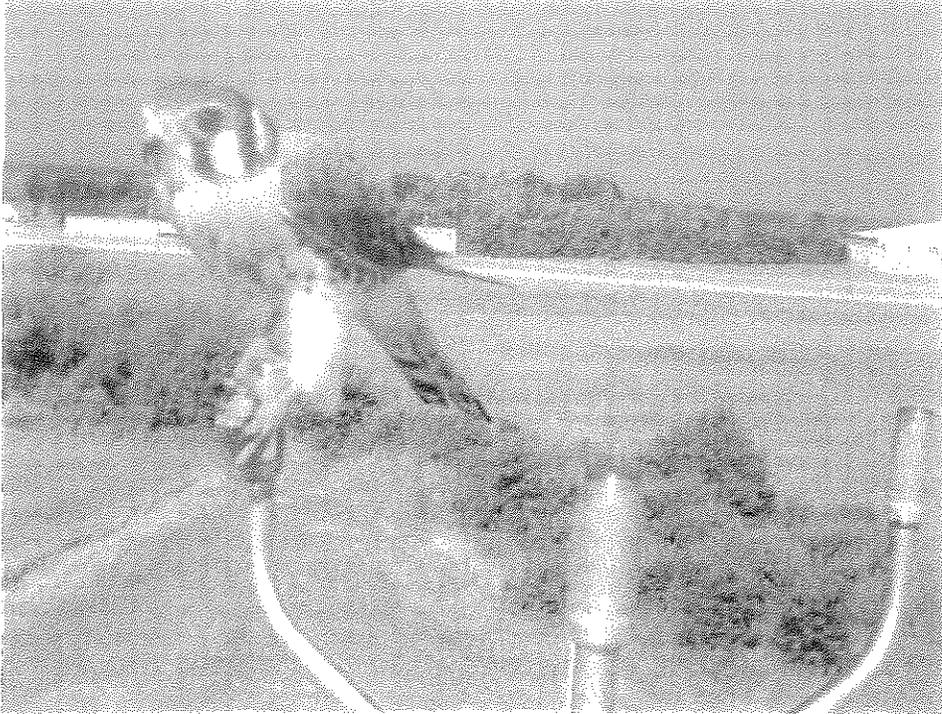
To determine what caused the false wind gusts, the NWS in Detroit was contacted and they confirmed having seen bird interference with the ultrasonic anemometer used on the ASOS. These anomalies involve birds landing on the anemometers. The ultrasonic anemometers use sound waves transferred between three transducers to calculate wind speed and direction. When one or all of these paths are broken, say from a bird landing on the anemometer (Figure 4), the internal sensor firmware occasionally reports inaccurate wind speeds. The FAA uses the same style ultrasonic anemometers on a number of automated weather systems and has documented similar problems with birds. No gusts were falsely reported on the WME because the anemometer used is mechanical in nature and not affected by birds.

Figure 4 – Example of bird perching on ultrasonic anemometer transducer

It is the belief of the meteorologist investigating this problem report that the cause of the differences in wind readings between the WME and ASOS on May 19, 2011 at 15:01 UTC was bird activity on ASOS anemometer transducers.

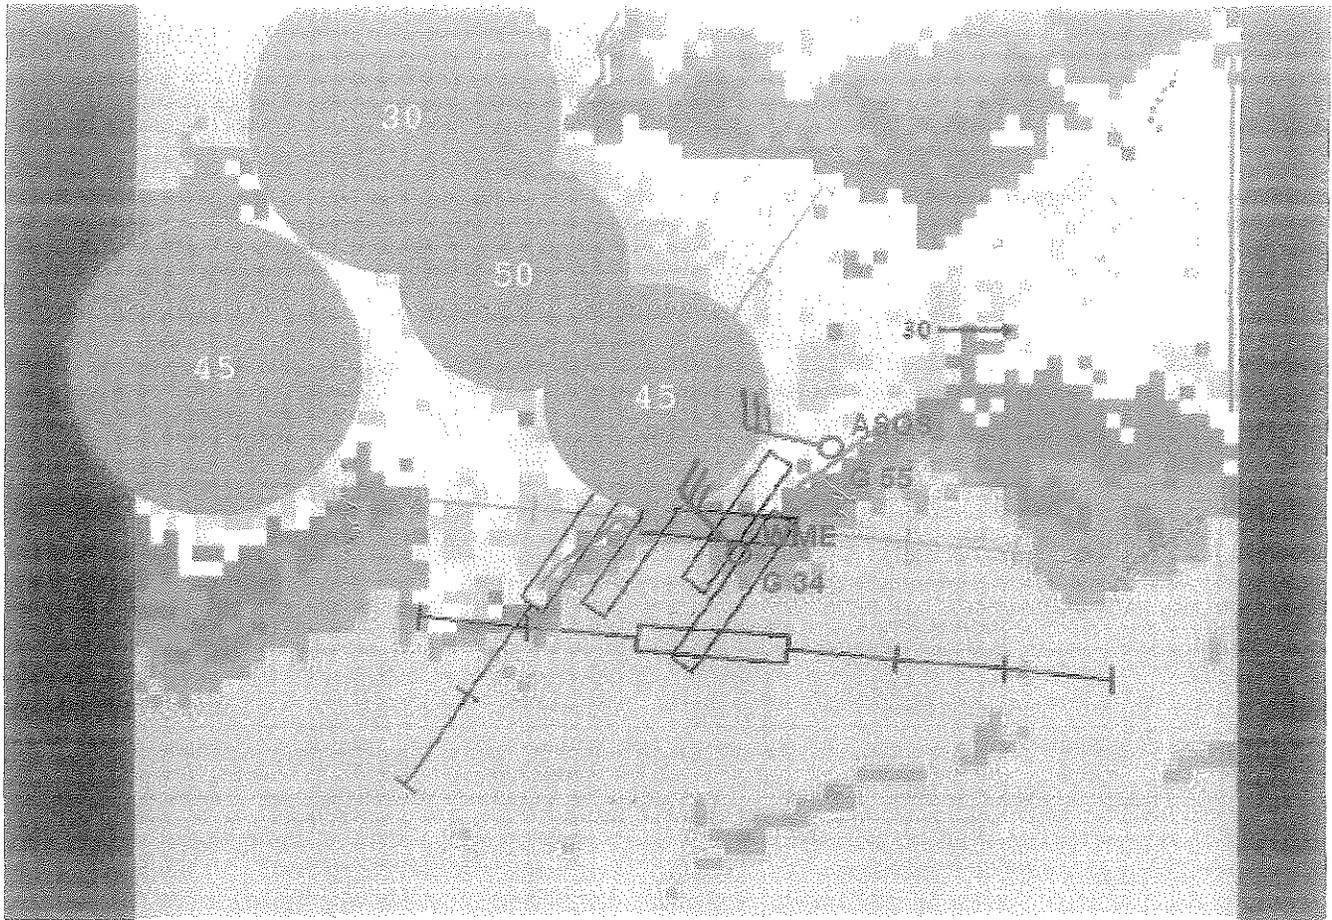
The winds at 00:01 at both the WME and ASOS indicate that they are on the periphery of the microburst. Strong northwest microburst outflow winds are reported at both locations (Figure 13). The WME reported a wind of 310° at 25 knots with gusts to 34 knots and the ASOS reported a wind of 280° at 25 knots with gusts to 55 knots. At 00:01 a special (SPECI) METAR report was issued. This ASOS report appears to be the wind referenced in the problem report.

Figure 13 – ASOS and WME winds on July 3, 2011 at 00:01 UTC

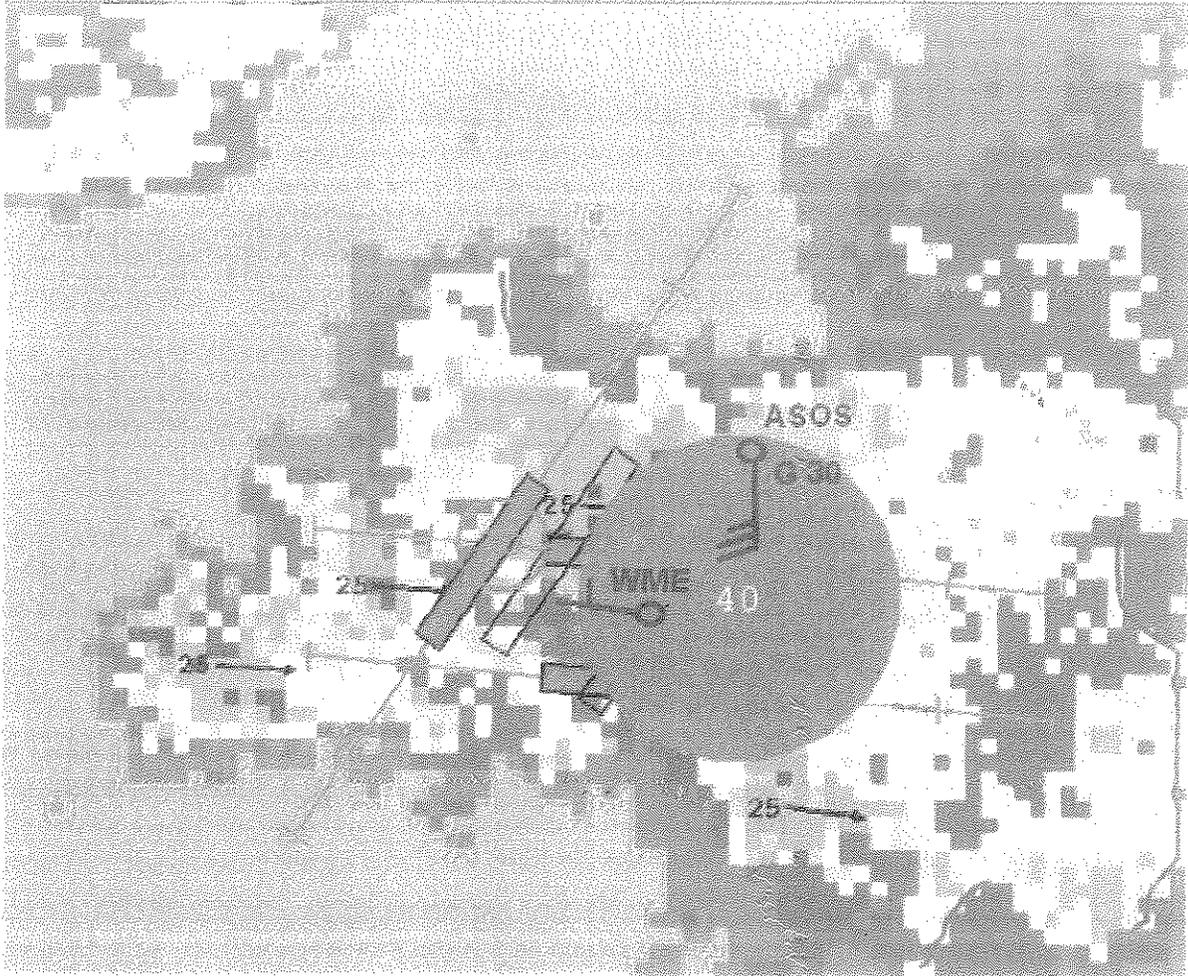
By 00:23 UTC (time of the problem report), the microburst moved to the southeast and is now centered very close to the WME. Light winds were evident by the WME (290° at 6 knots) as it was located close to the center of the microburst. Two minutes later the WME winds are reported as calm, an indication that the microburst is directly on top of the WME. This is confirmed by the microburst shape and alerts generated by ITWS (Figure 14 and Figure 15). At the same time the ASOS is located on the northern periphery of the microburst and is experiences strong outflow winds. A strong southerly outflow was evident in the ASOS at 00:23 UTC (190° at 26 knots with gusts to 30) and is what should be expected with a microburst located to the south.

Figure 14 – ASOS and WME winds on July 3, 2011 at 00:23 UTC

It is the belief of the meteorologist investigating this problem report that the cause of the differences in wind readings between the WME and ASOS on July 3, 2011 at 00:23 UTC was microburst activity in the area. Both the WME and ASOS appeared to be working properly and accurately measured winds associated with an ongoing microburst centered on the east side of the DTW airfield.

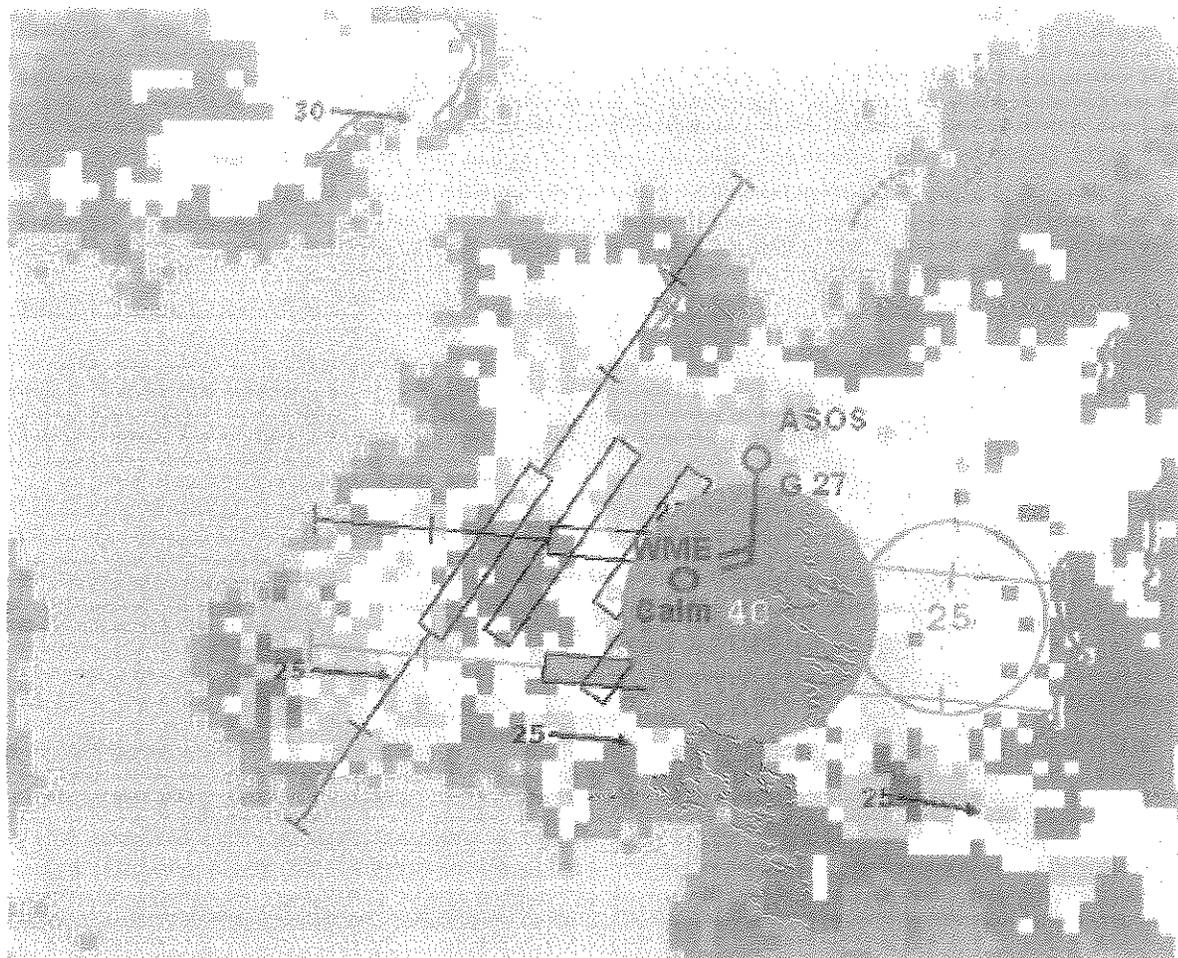
Figure 15 – ASOS and WME winds on July 3, 2011 at 00:25 UTC

In summary, strong outflow winds were observed at both the WME and ASOS as a strong microburst outflow approached DTW on July 3, 2011. At the time of the problem report the WME was near the center of the microburst with virtually calm winds. The ASOS on the northern periphery of the microburst detected strong southerly outflow winds. Both sensors appear to be providing accurate wind information at the time of the event and provided ground truth to validate the microbursts generated by ITWS.
