Office of the Naval Inspector General

OSC Case Number DI-08-0177
NAVINGEN Case Number 20070925
NAVAIR Case Number H2007-170
FRCSE Case Number H2007-096

Report of Investigation

Subj: ALLEGED SYSTEMATIC ABUSE OF MAINTENANCE AND CERTIFICATION PROCEDURES, INCLUDING THE UNLAWFUL DISPOSAL OF HAZARDOUS MATERIAL AND IMPROPER CLEANING AND REPAIR OF JET ENGINES AT FLEET READINESS CENTER SOUTHEAST (FRCSE), JACKSONVILLE, FLORIDA.

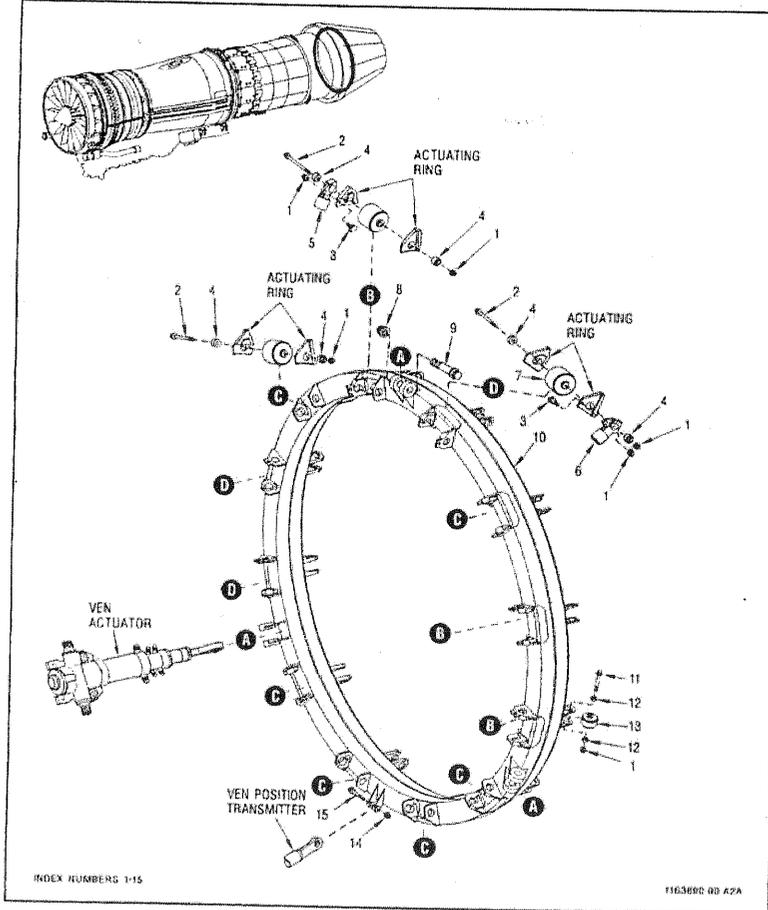
Figure 1 Breakdown of VEN

16. Figure 1 shows the breakdown of a VEN.⁴ Item 5 is a side roller; item 7 is a cam roller; item 13 is a compression roller.
