Vincent M. Sugent  
7768 Pleasant Lane  
Ypsilanti, MI 48197  
January 9, 2012

Existing and Proposed ASOS and WME Locations  
Detroit Metropolitan Wayne County Airport, MI (DTW)

**Automated Surface Observing System (ASOS)  
and  
Wind Measuring Equipment (WME)**

**Detroit Metropolitan Wayne County Airport  
Detroit, MI (DTW)**

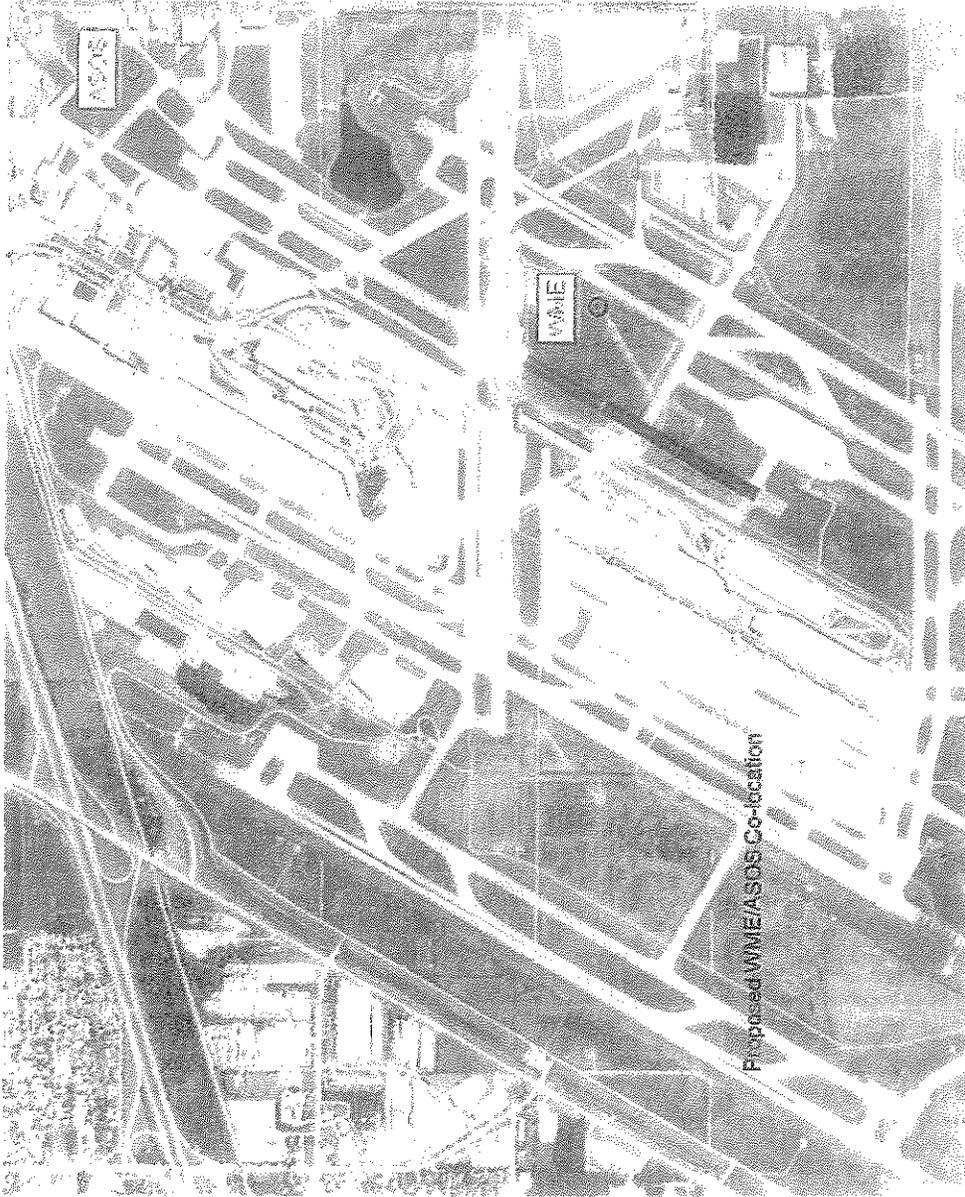
A meteorological survey and obstruction analysis were performed at the existing WME and ASOS locations. There were no obstructions noted at the WME location that would adversely affect wind readings. There were a number of aircraft hangars to the east of the existing ASOS location that are likely causing sheltering. Given the height and location of these structures, the DTW ASOS is in violation of the ASOS Siting Order. See pages 4-10 for more details on the evaluation of the existing WME and ASOS locations.

A formal survey was conducted to locate a site to co-locate the ASOS and WME. A location near the ASOS Data Collection Package (DCP) near Runway 04R glide slope tower was selected for both systems. No significant obstructions to the prevailing wind in the area were noted. Both anemometers can be installed on 33-foot poles at this location.

It is the recommendation of AJW-14A, with input from DTW Air Traffic, Tech Ops and the National Weather Service to proceed with the Needs Assessment Program (NAP) entry, initiated by DTW TechOps, to relocate the WME and ASOS wind equipment to the ASOS Data Collection Package (DCP) near Runway 04R glide slope tower. Refer to pages 11-13 for site details, map and photographs.

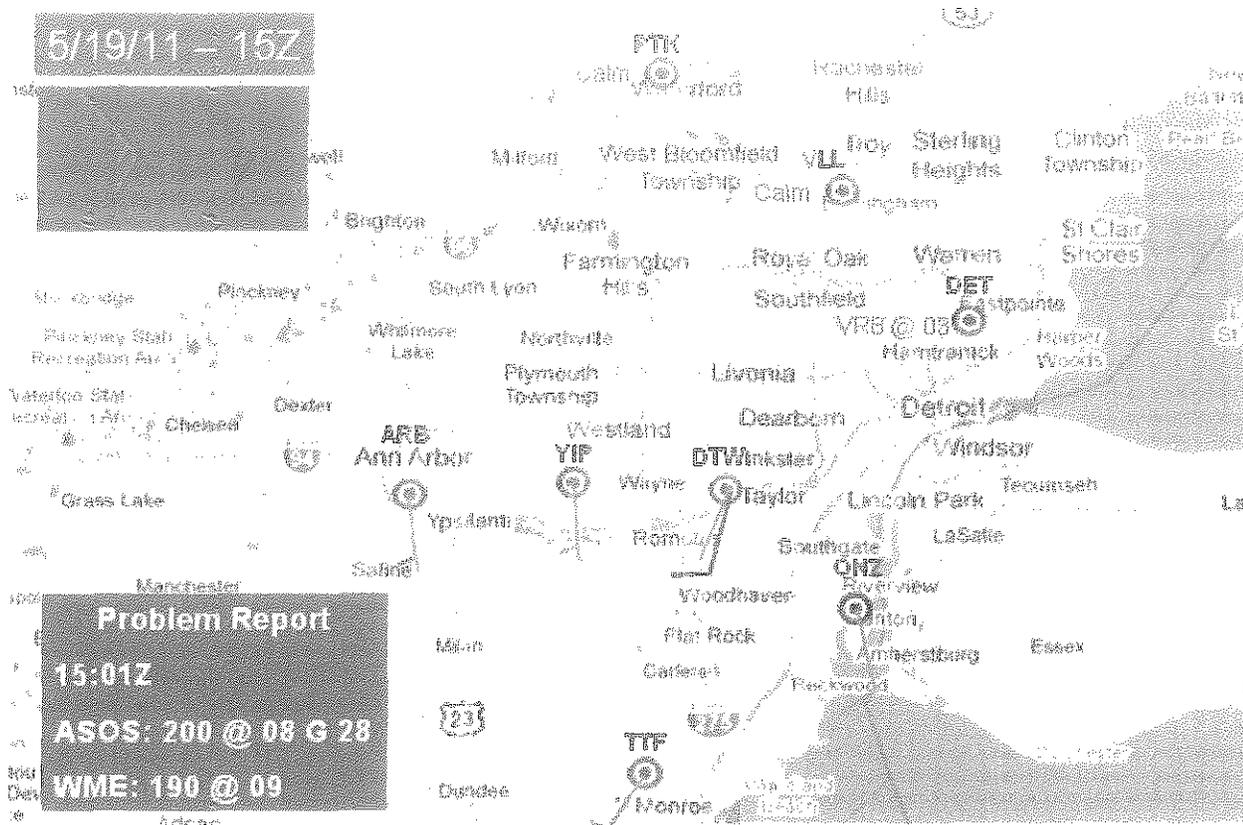
Figure 3 – Hourly METAR Summary for May 19, 2011 (15:00 UTC)

The winds reported on the ASOS were 200° at 08 knots with gusts to 28 knots. The winds reported on the WME were 190° at 09 knots with no gusts. A review of the hourly METARs from around the DTW area (Table 2 and Figure 3) show that the winds were generally light out of the south with a few sites reporting calm winds. None of the airports reported any gusts.

A closer look at the DTW METARs show no gusts reported in any hourly observation for the entire day. The DTW ASOS is augmented by a contract weather observer. The contract weather supervisor, Ed Burney, was contacted and confirmed that the contract weather observers have the ability to remove invalid wind gusts if they are perceived to be inaccurate utilizing other available wind sources (e.g., airport wind socks). If the peak winds on the ASOS, seen in the ATCT during the problem report, were not contained in the hourly METAR then the contract weather observer determined it was invalid and was removed.

To determine what caused the false wind gusts, the NWS in Detroit was contacted and they confirmed having seen bird interference with the ultrasonic anemometer used on the ASOS. These anomalies involve birds landing on the anemometers. The ultrasonic anemometers use sound waves transferred between three transducers to calculate wind speed and direction. When one or all of these paths are broken, say from a bird landing on the anemometer (Figure 4), the internal sensor firmware occasionally reports inaccurate wind speeds. The FAA uses the same style ultrasonic anemometers on a number of automated weather systems and has documented similar problems with birds. No gusts were falsely reported on the WME because the anemometer used is mechanical in nature and not affected by birds.

It is the belief of the meteorologist investigating this problem report that the cause of the differences in wind readings between the WME and ASOS on May 19, 2011 at 15:01 UTC was bird activity on ASOS anemometer transducers.

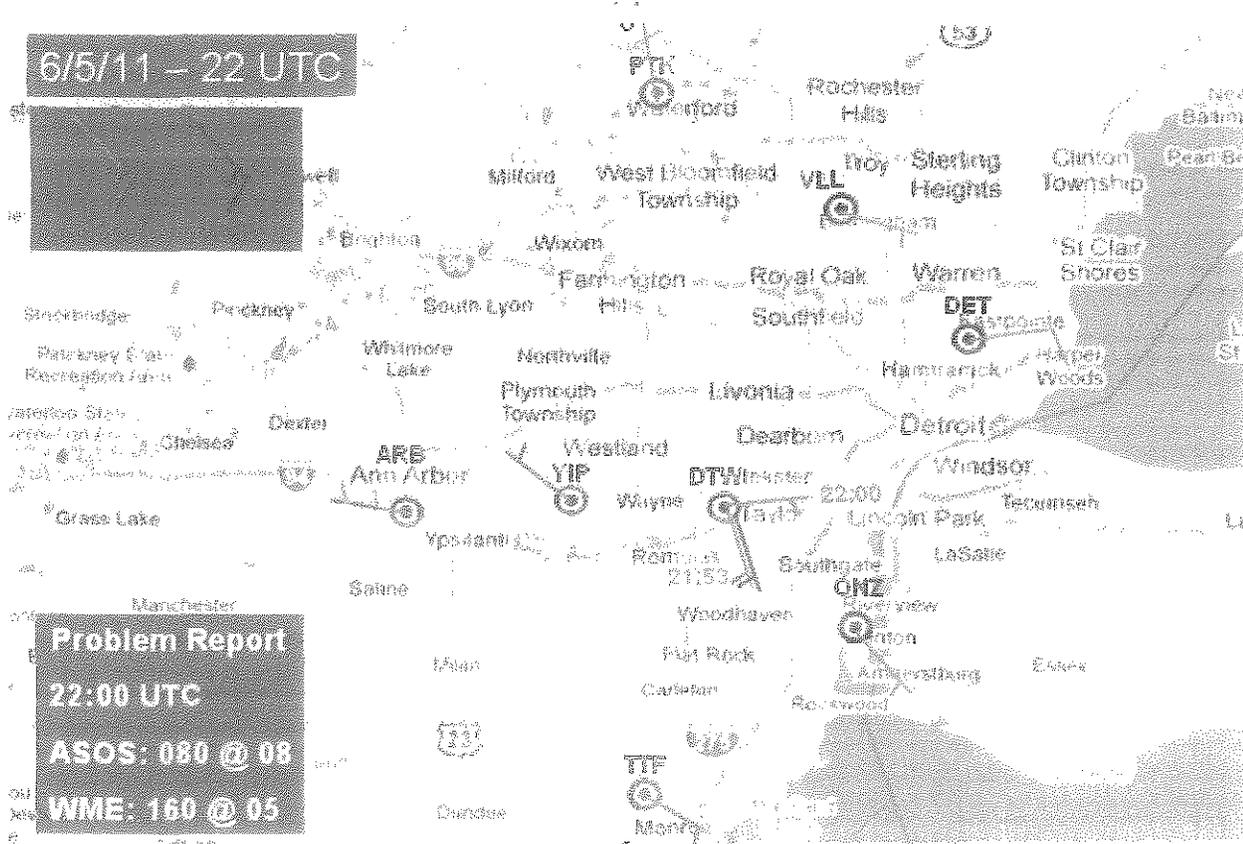
Figure 6 – Hourly METAR Summary for June 5, 2011 (22:00 UTC)

A review of the hourly METARs from around the DTW area (Table 3 and Figure 6) show that the wind speeds at all reporting stations were less than 10 knots with variable directions.

It is the belief of the meteorologist investigating this problem report that the cause of the differences in wind readings between the WME and ASOS on June 5, 2011 at 22:00 UTC was the fact that the winds were light and variable throughout the Detroit metropolitan area. Comparisons in wind direction between anemometers should only be made when the prevailing wind speed is at least 10 knots

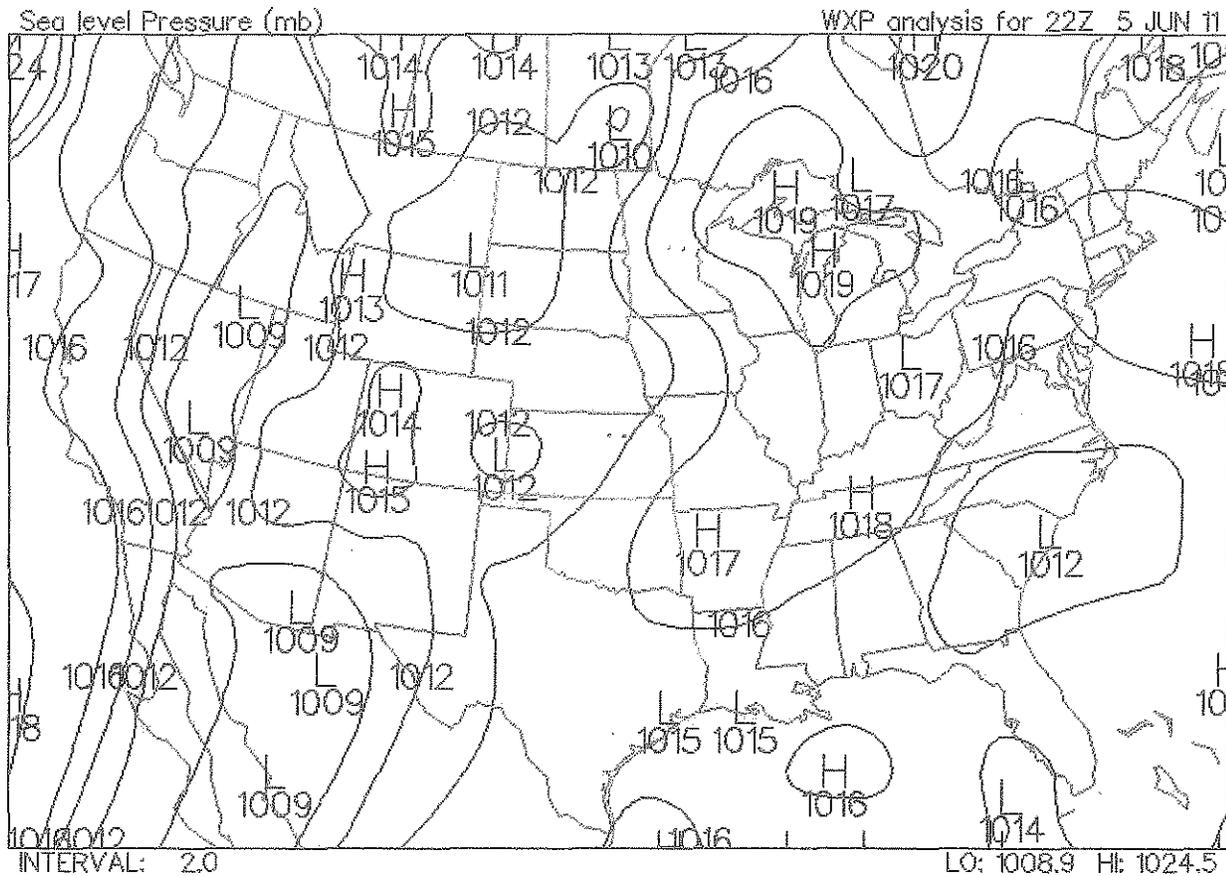
Figure 7 – Surface Pressure Map at 22:00 UTC on June 5, 2011

At 22:00 UTC high pressure was located over northern Michigan (Figure 7). There was a very weak atmospheric pressure gradient leading to light winds across the region. In addition to causing light wind speeds, a weak pressure gradient often leads to variable wind direction. When the pressure gradient is strong and the resultant wind speeds are high, the moving air has a higher momentum which tends to resist changes in direction. The wind direction therefore is governed by the pressure gradient and its orientation (synoptic scale flow). However, when the pressure gradient is weak and the wind speeds are light, small scale features, such as thermal eddies and temperature and density boundaries, play a direct role in determining the wind direction.

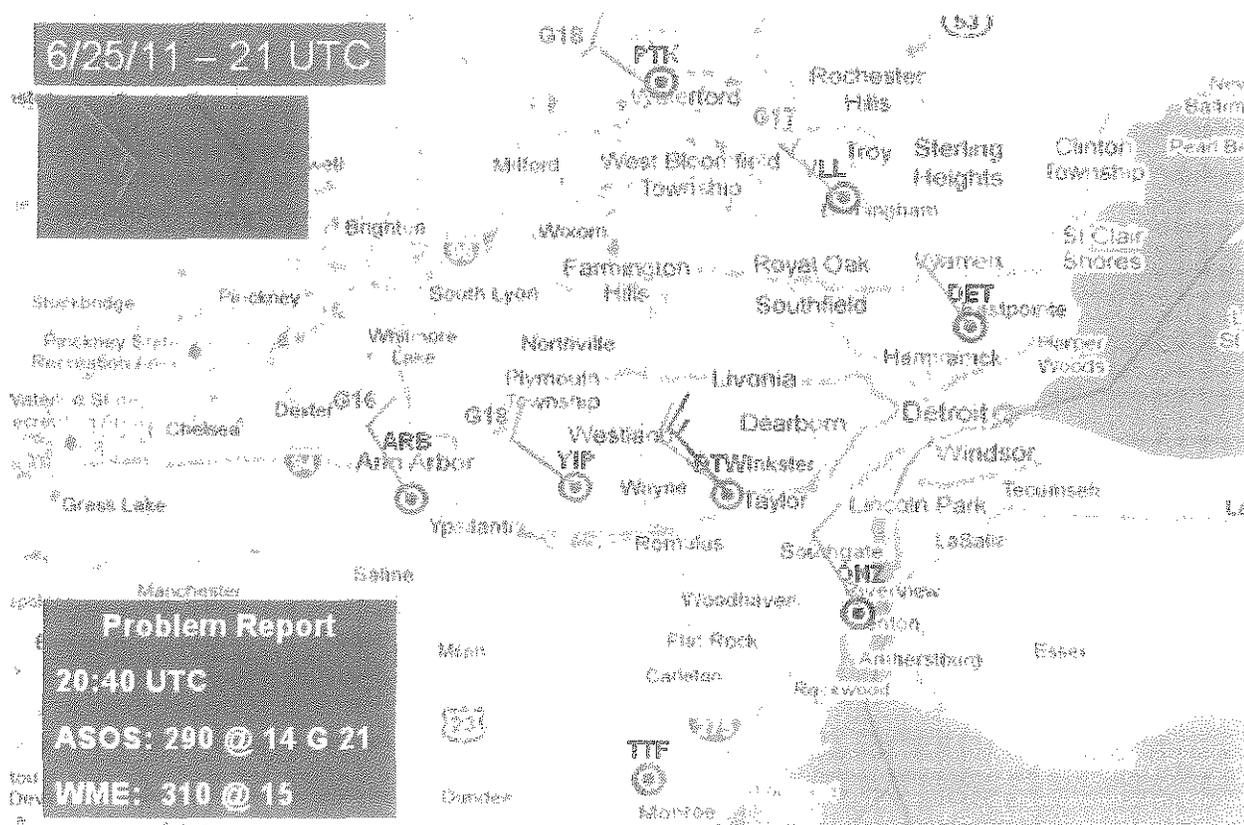
Figure 9 – Hourly METAR Summary for June 25, 2011 (20:40 UTC)

A look at the hourly METAR observations (Table 4 and Figure 9) indicate strong northwesterly winds at all locations. Most sites had sustained winds around 10 knots with some sites reporting gusts in excess of 15 knots. The gust threshold for both the ASOS and WME at DTW is 5 knots. That means that a gust will be reported if the peak wind observed is greater than the two minute average by 5 knots or more.

To explain why no gust was reported by the WME, the criteria for retaining a gust needs to be discussed. Once a gust is observed on the WME it will continue to be reported for 10 minutes,

It should also be noted that during the hourly METAR observation taken 13 minutes after the trouble report, the DTW ASOS no longer carried the gust. Often with this type of situation, one system will report a gust and the other do not quite meet the 5 knot criteria for gust.

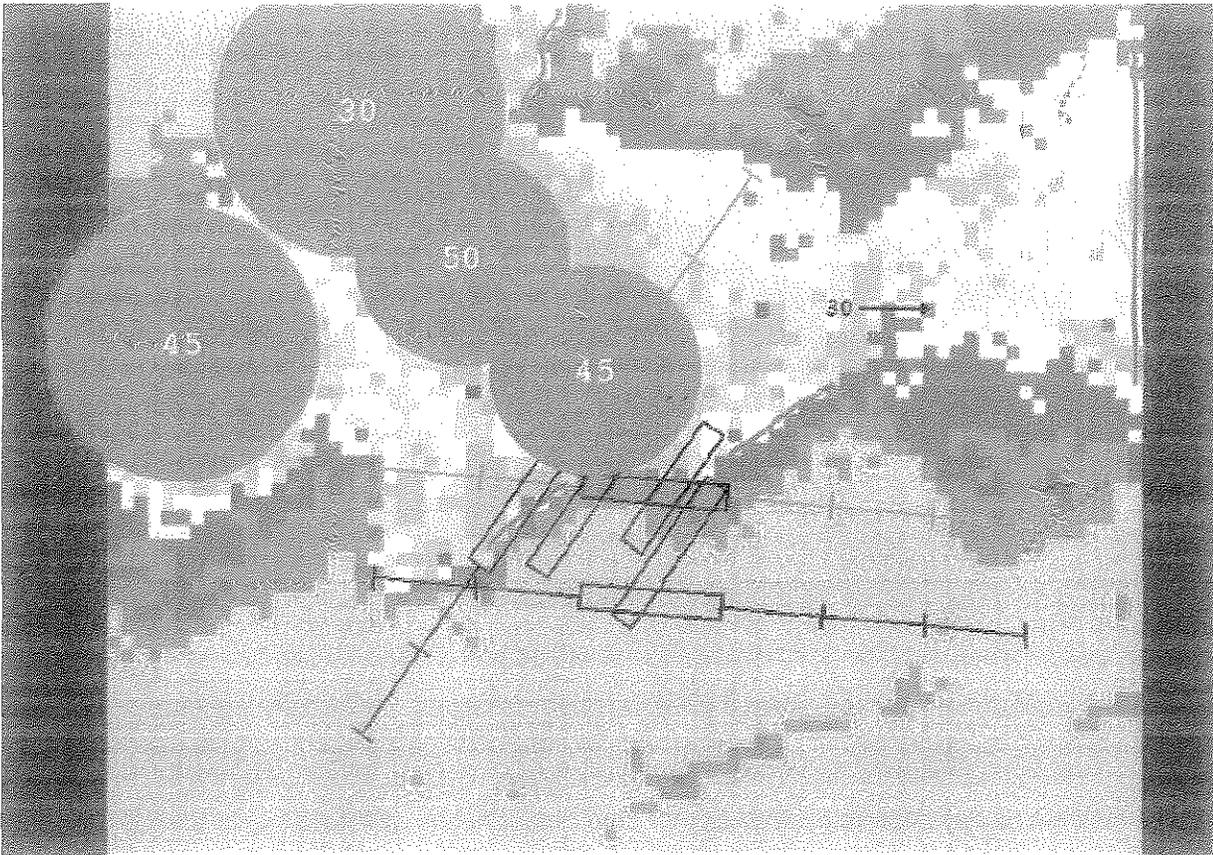
Figure 11 – ITWS Alerts on July 3, 2011 at 00:01 UTC

Prior to the problem report, a strong complex of thunderstorms was located to the northwest of DTW. Numerous microbursts detections were made by the ITWS. No alerts were valid for any runway at this time. By 00:01 UTC, the thunderstorm complex had slowly moved to the southeast and was now impacting the northwest portion of the airport (Figure 11). Microburst alerts of 45 knots were being issued for Runways 4L-22R, 4R-22L, and 9L-27R.

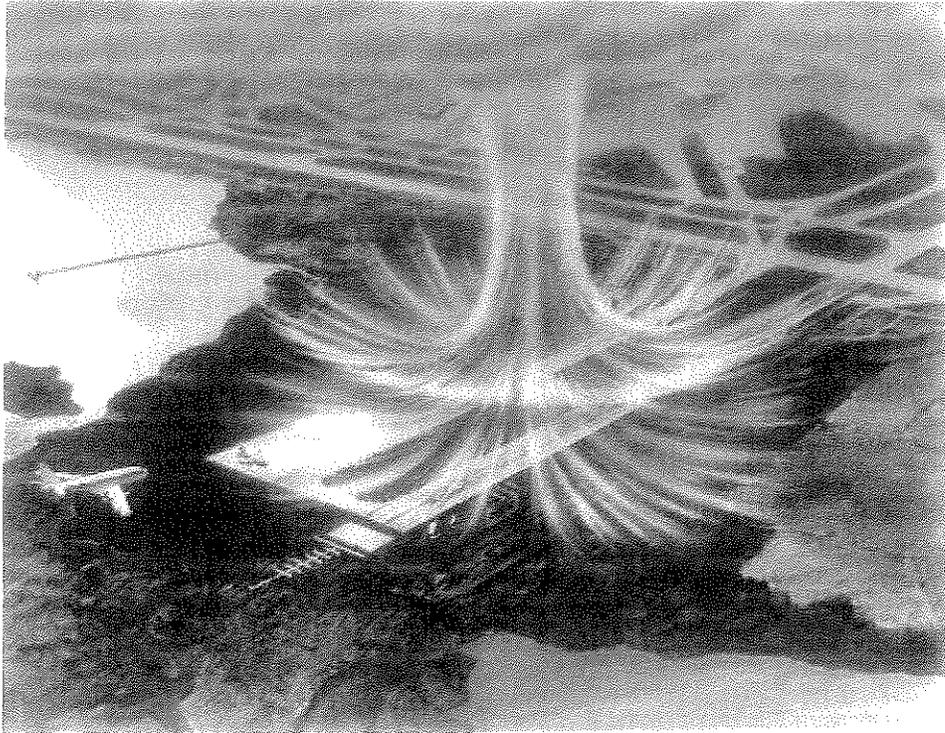
Figure 12 – Conceptual drawing of a microburst

The three dimensional structure of a microburst (Figure 12) reveals a rapid descent of air near the center of the microburst. Upon reaching the ground the air spreads out and often produces very strong winds along the periphery of the microburst. Virtually all wind is along a vertical axis near the center of the microburst. Since an anemometer is designed to detect only horizontal winds, an anemometer directly under the microburst will report very little horizontal winds.

The winds at 00:01 at both the WME and ASOS indicate that they are on the periphery of the microburst. Strong northwest microburst outflow winds are reported at both locations (Figure 13). The WME reported a wind of 310° at 25 knots with gusts to 34 knots and the ASOS reported a wind of 280° at 25 knots with gusts to 55 knots. At 00:01 a special (SPECI) METAR report was issued. This ASOS report appears to be the wind referenced in the problem report.
