**Analysis of Disclosures, Agency Investigation and Reports,  
and Whistleblower Comments**

**OSC File Nos. DI-08-0591 and DI-08-1696**

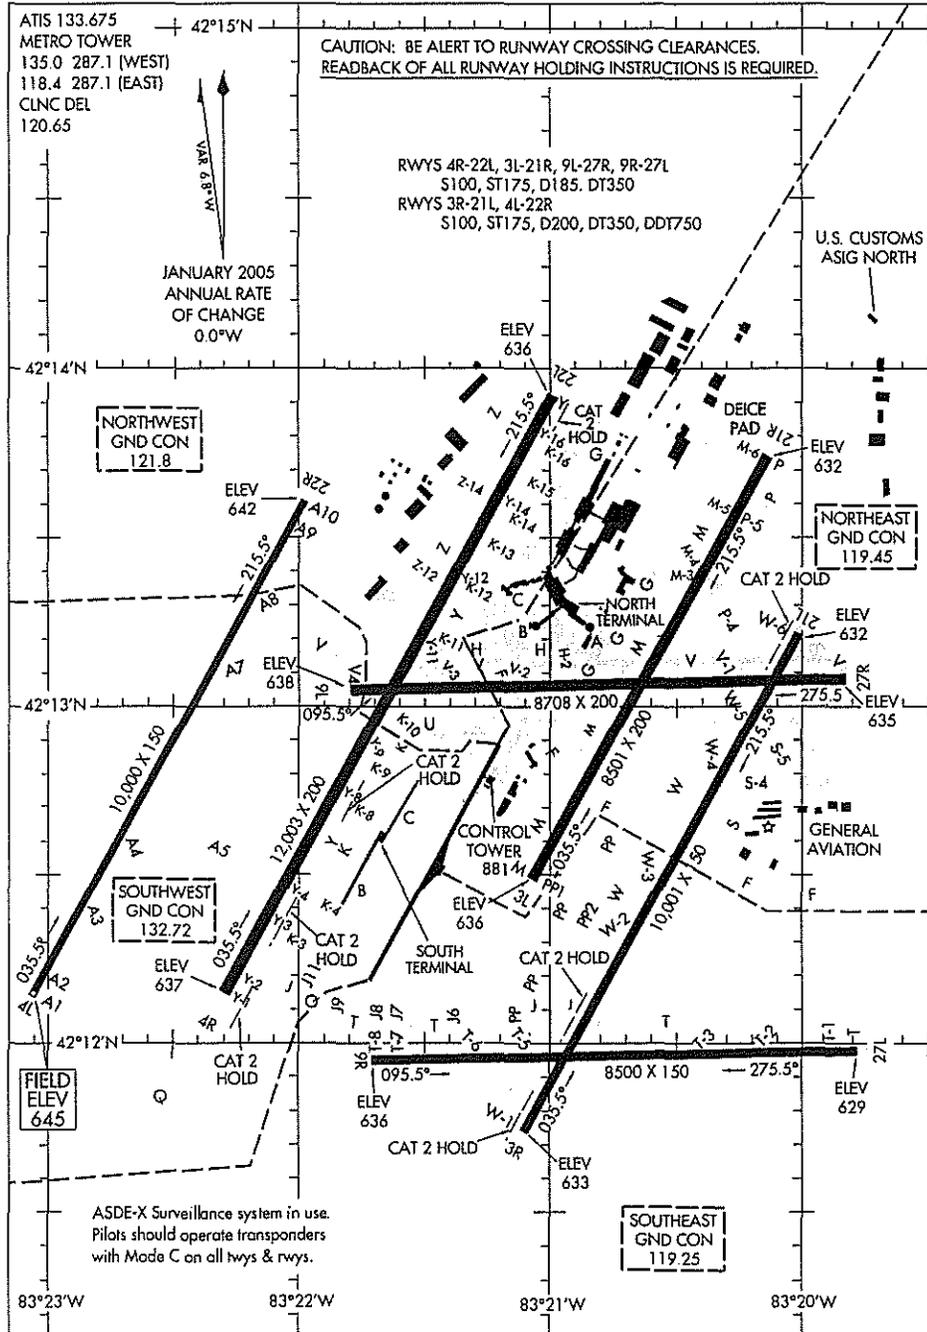
# AIRPORT DIAGRAM

DETROIT METROPOLITAN WAYNE COUNTY (D'T'W)  
AL-119 (FAA)  
DETROIT, MICHIGAN

Mr. Sugent alleged that air traffic controllers (controllers) were concerned about the flight operations on intersecting runways when the airport runs a configuration known as the Southwest Flow.<sup>2</sup> The Southwest Flow occurs when FAA Management officials direct

Mr. Sugent further states that he showed clearly in video playbacks that a runway 22L departure is just as unsafe as a runway 21R departure when an aircraft goes around on runway 27L, if not more so. Management has attempted to draw a distinction between dependent (departing runway 21R when arriving 27L) and independent (departing 22L, arriving 27L), without providing any guidance or official definition of dependent vs.
