Vincent M. Sugent
7768 Pleasant Lane
Ypsilanti, MI 48197
September 11, 2012

Thank you again for your time, patience and effort in addressing safety issues and improprieties with Detroit Tower and the Agency. The following is offered as a response to DI-11-1675 and DI-11-1677 supplemental information received July 2012 from the Agency.

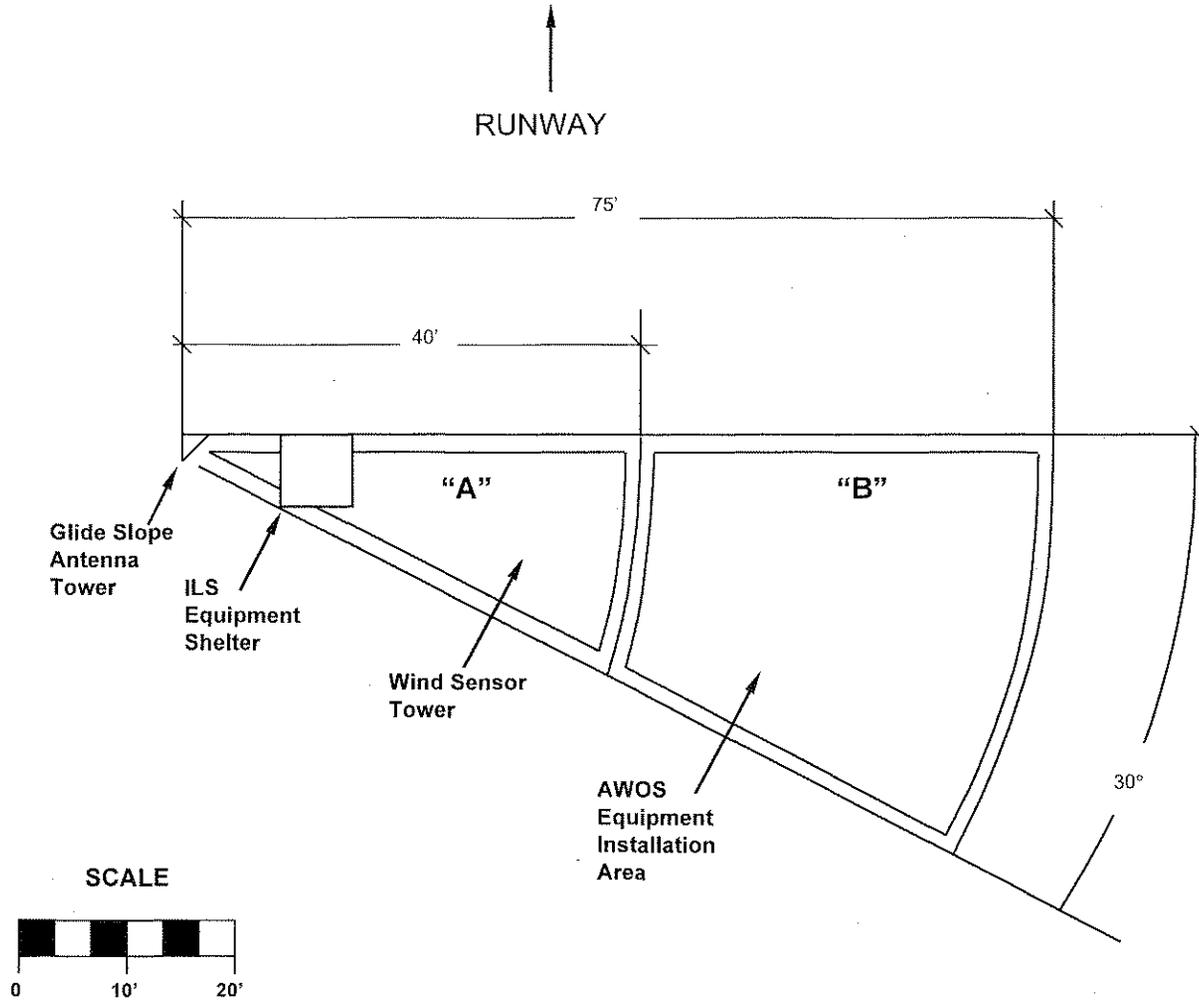
Exception: The height of a wind sensor installed on the Instrument Landing System (ILS) glide slope antenna tower or on a separate tower in area "A," figure 1, section 3, will be reduced, as necessary, such that the height of the complete wind sensor installation (i.e., to include any required air terminal(s) and obstruction lights) does not exceed the height of the glide slope antenna installation. The minimum acceptable height for the wind sensor in this situation is 20 feet (6 meters). If side mounting (i.e., perpendicular to a tower) is necessary, a boom will be used to permit installation of the sensor at a minimum of 3 feet (1 meter) laterally from the tower. Side mounting is to be utilized only if top mounting is not practicable and the tower is of open design to allow for free air flow.

3.2.4 Airports with Precision Instrument Runways and with RVR Instrumentation. The cloud height, visibility, and wind sensors and associated DCP shall be sited at a location on the airport that will assure the resultant observations are representative of the meteorological conditions affecting aviation operations, and that meets the sensor exposure criteria outlined in section 2. However, no sensor siting shall violate runway or taxiway object free areas, runway or taxiway safety areas, obstacle free zones, or instrument flight procedures surfaces as described in AC 150/5300-13, Airport Design, or FAA Handbook 8260.3, TERPS.

Figure 1. Precision Instrument Runway Siting (Plan View)

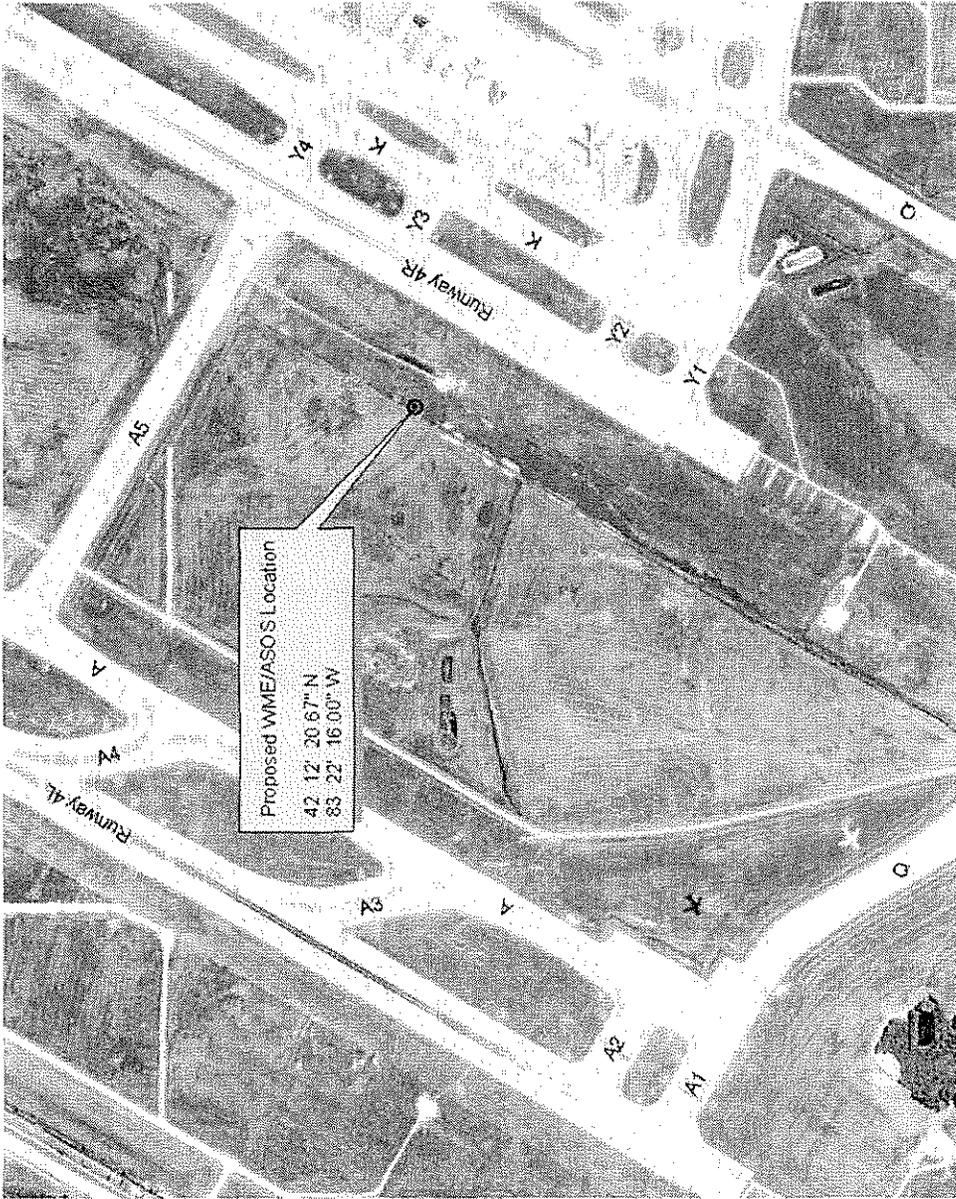
DTW Proposed WME and ASOS Site

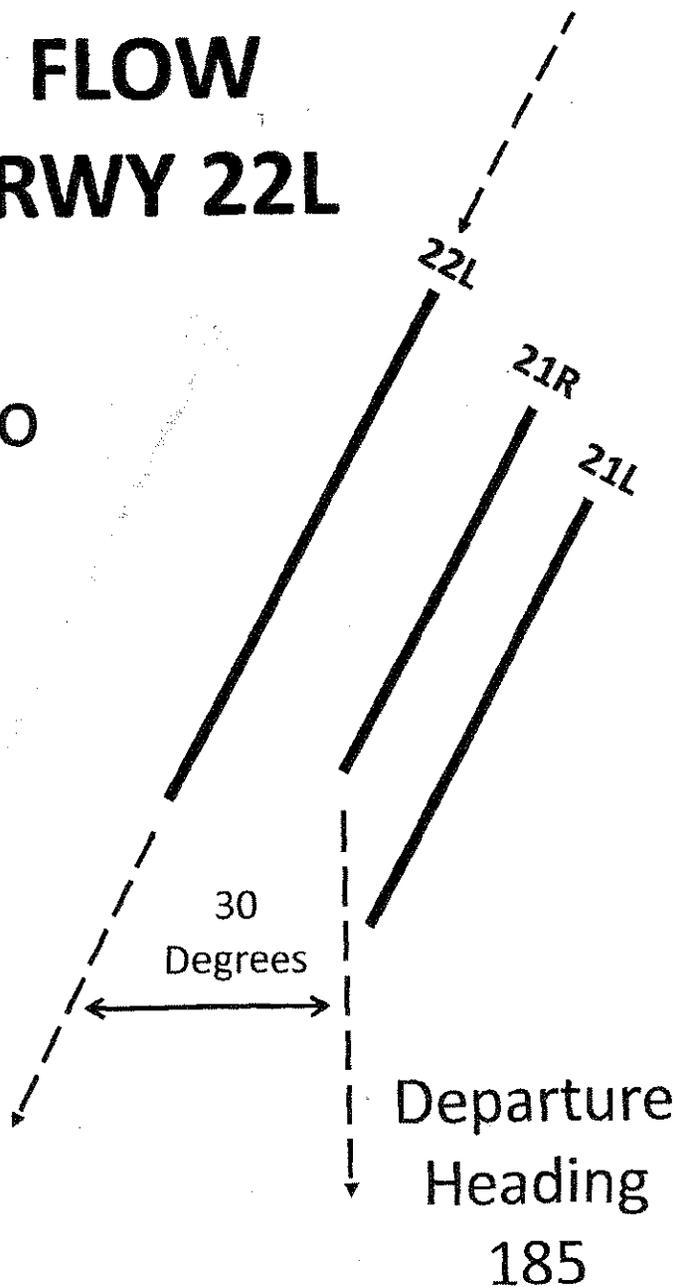
Simultaneous
Operations
Allowed when
Departing RWY
21R or 21L on a
185 Heading

SOUTH FLOW Landing RWY 21L

Simultaneous
Operations
Allowed when
Departing
RWY 22L

2 Increasing
to 3 when
departing
RWY 21R or
21L
