**Analysis of Disclosures, Agency Investigation and Reports,
and Whistleblower Comments**

**OSC File Nos. DI-11-1675 and DI-11-1677
(Vincent Sugent and Brian Gault, Detroit, MI)**

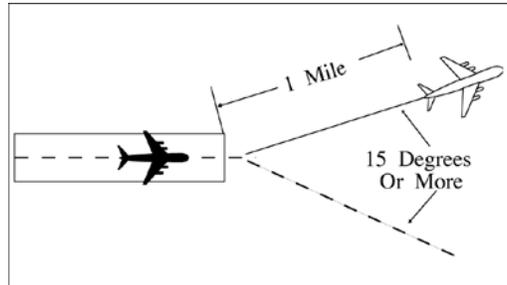
FIG 5-8-1
Successive Departures

FAA Order 7110.65, Paragraph 5-8-3 governs successive or simultaneous departures in a radar controlled environment. It requires that controllers separate aircraft departing from the same airport by the number of miles specified in the paragraph, provided, in pertinent part, that the courses of the aircraft will diverge by 15 degrees or more. This means that controllers must provide appropriate headings to departing aircraft to comply with this provision. If, for example, aircraft are departing from the same runway one after another, the courses must diverge by 15 degrees or more within 1 mile of the departure end of the runway, as reflected below in Figure 5-8-1. (Paragraph 5-8-3a.) This is also true for simultaneous departures on two parallel runways, where the aircraft must immediately diverge by 15 degrees or more, as reflected below in Figure 5-8-7. (Paragraph 5-8-3c.)

At DTW when aircraft are departing on two departure runways (usually runway 4R and runway 3L in the north flow), controllers are required to use *both* Paragraph 5-8-3a for same-runway separation, and Paragraph 5-8-3c for adjacent runway separation. Usually, this will be manifested in the following headings: 360 and 20 degrees on Runway 4R, and 40 and 55 degrees on runway 3L. For successive departures from runway 4R the aircraft must diverge by 15 degrees within one mile of the departure end. For simultaneous departures from runway 4R and runway 3L, the courses must diverge by 15 degrees immediately upon departure.

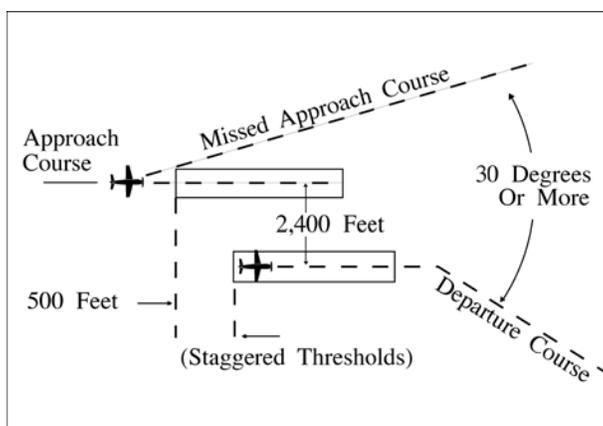
FIG 5-8-11
Parallel Thresholds are Staggered

Paragraph 5-8-5 permits the authorization of simultaneous operations between an aircraft departing on a runway and an aircraft on final approach to another parallel or nonintersecting diverging runway if the departure course diverges immediately by at least 30 degrees from the missed approach course until separation is applied, provided certain minimum conditions are met. Controllers at DTW are authorized to use the simultaneous operations as described in Paragraph 5-8-5. At DTW, the parallel thresholds are staggered and the 30 degree divergence requirement is reflected below in Figure 5-8-11.³

The November 30, 2011 agency report found that, depending on the specific circumstances under which their use is attempted, FAA Order 7110.65, Paragraphs 5-8-3 and 5-8-5 cannot be simultaneously followed at DTW. According to AOV experts, the Order's separation rules are conditional and cannot always be used simultaneously. In DTW's case, both Paragraphs 5-8-3 and 5-8-5 can be adhered to if arrivals and departures are managed in a manner that does not result in simultaneous operations on all four parallel runways at the same time. According to the report: "If, however, two aircraft depart DTW while two other aircraft are simultaneously on final approach and, depending upon the specific circumstances of the event, e.g., timing and distance between flights, the controller will need to rely on other rules to permit the operation." Moreover, given DTW's airspace and the "specific geometry of the instrument flight procedures established there, along with the speed and turning capabilities of aircraft," it may not be possible for controllers to issue headings to departures that will allow for the required 30-degree divergence for the arrival's missed approach course.
